This document will trace the progress of the building at the University of KwaZulu-Natal, Chemical Engineering Building, basement, Pollution Research Group. This document will be updated every week to keep track and progress of the building taking place and at large serve as the building portfolio.

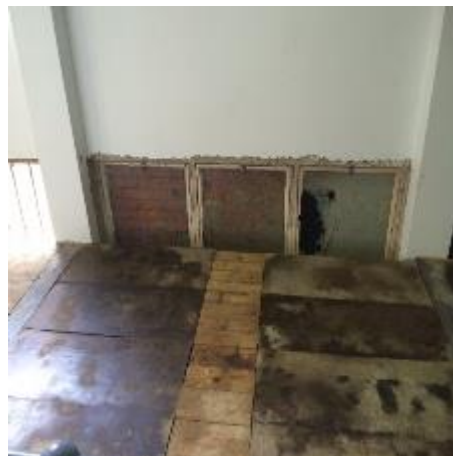
Figure 2: Windows behind the wall caused delays.

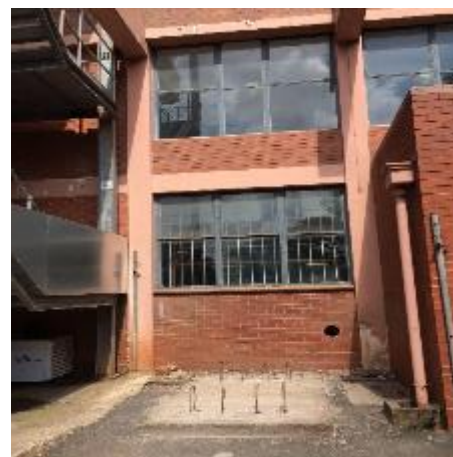
Figure 4: Wash station with drilled hole and filters removed.

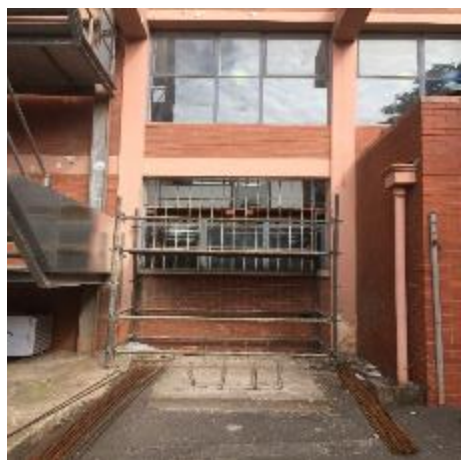
Figure 4: Wash station with hole and scaffolding staging and filters removed.

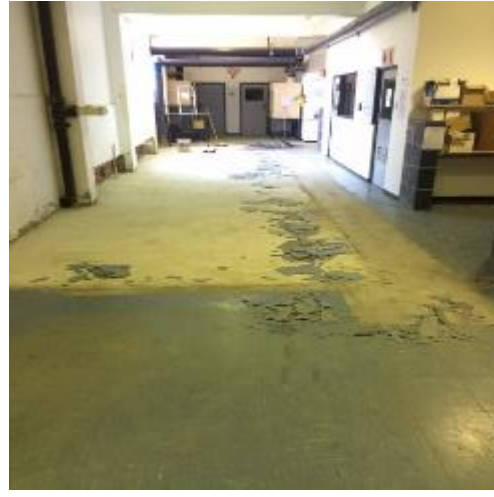
Figure 2: Removal of tiles in basement 1.

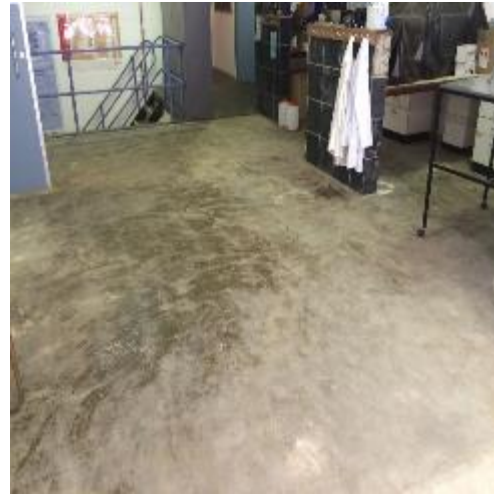
Figure 2: Tiles in Basement 1 completely removed on the floor.

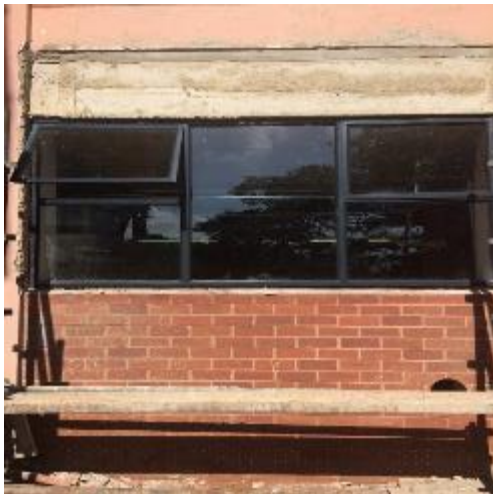
Figure 3: New window installed on the wash basin wall area.

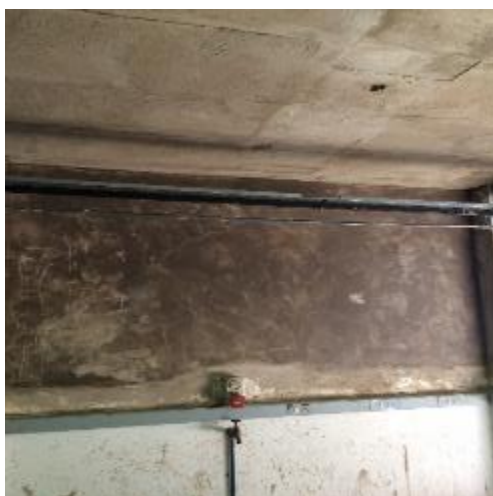
Figure 5: The window that was taken down and cause delays has been sealed.

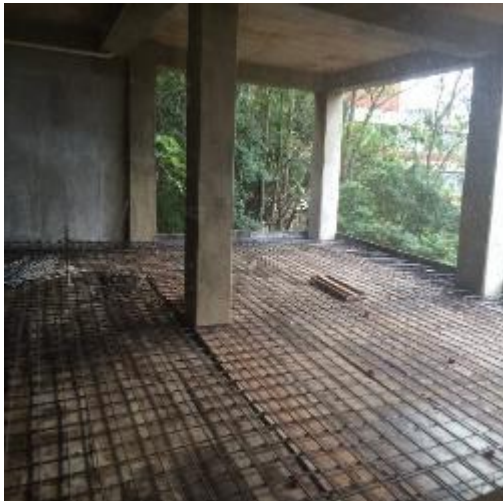
Figure 3: New slab foundation with grid layer (underpinning) View from the office window.

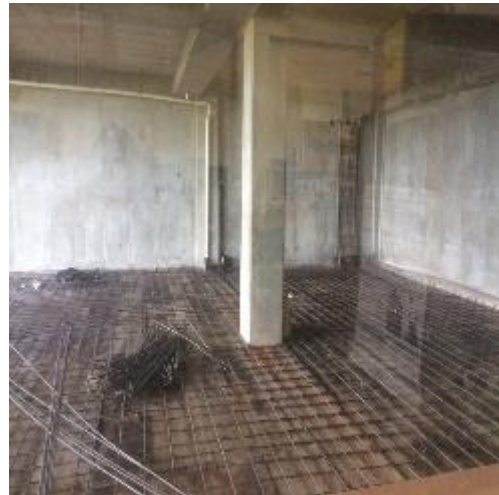
Figure 4: New slab foundation with grid layer (underpinning), above gas cylinder area 2.

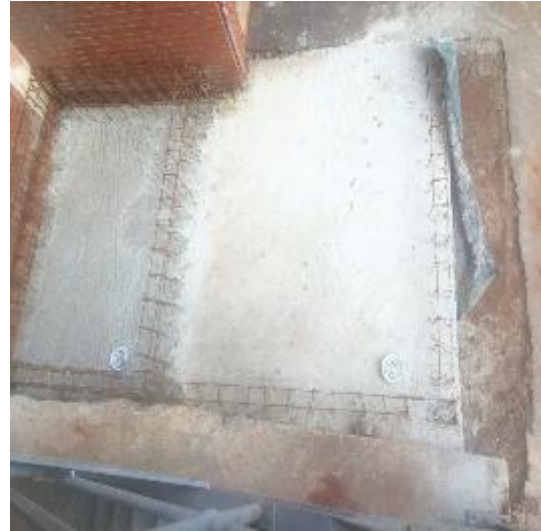
Figure 2: Wash basin foundation, covered with cement and protruding grid.

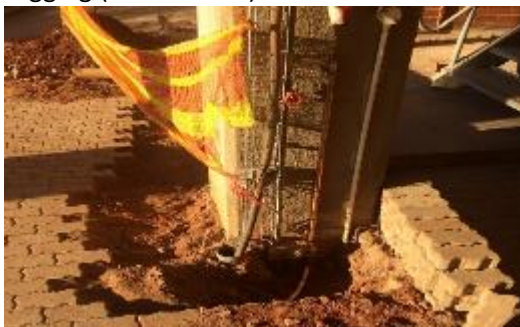
Digging (excavations) outside the wash area and emergency exit stairway.
