This document aims to trace the progress of the building of the Pollution Research Group at the basement of Chemical Engineering Building, University of KwaZulu-Natal. This document will be updated regularly to keep track of the progress of the building alterations taking place.

29 January 2016

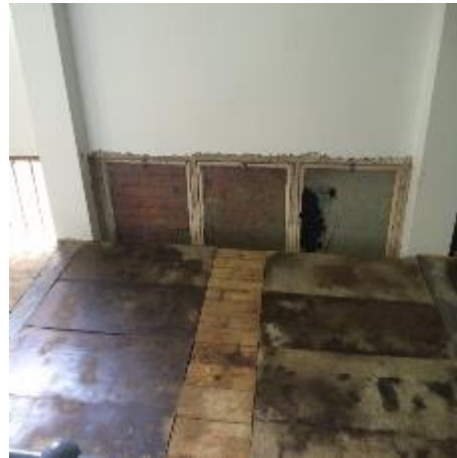
Figure 2: Windows behind the wall caused delays.

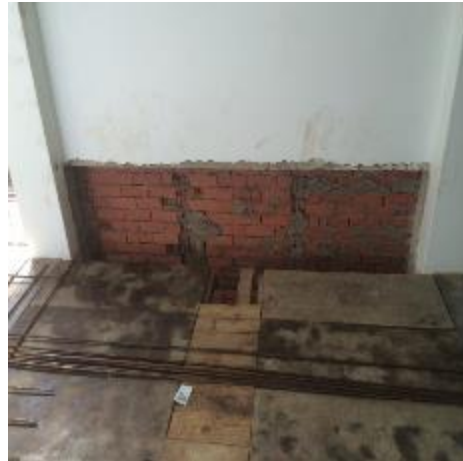
Figure 2: Windows panes removed.

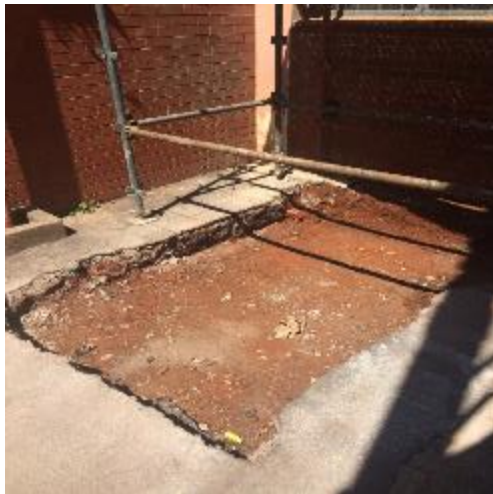
Figure 3: Concrete removed from the wash basin area.

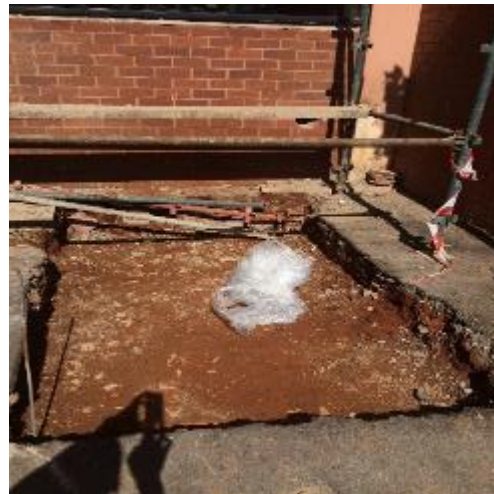
Figure 4: Tar concrete removed from the wash station.

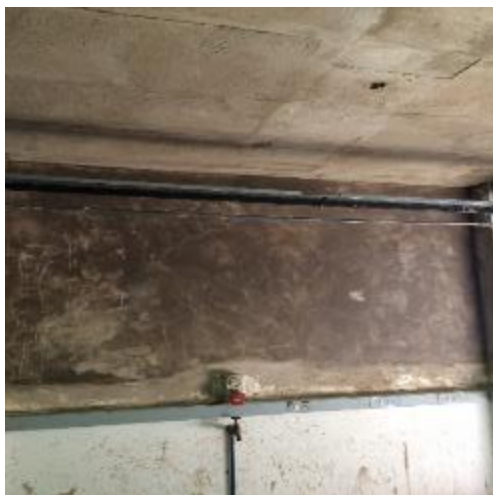
Figure 5: The window that was taken down and cause delays has been sealed.

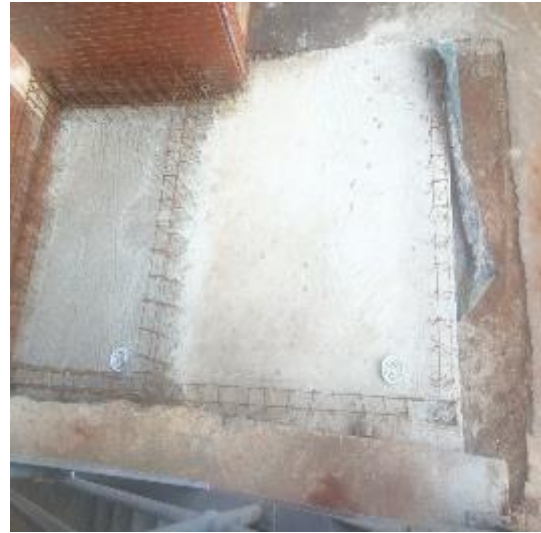
Figure 2: Wash basin foundation, covered with cement and protruding grid.

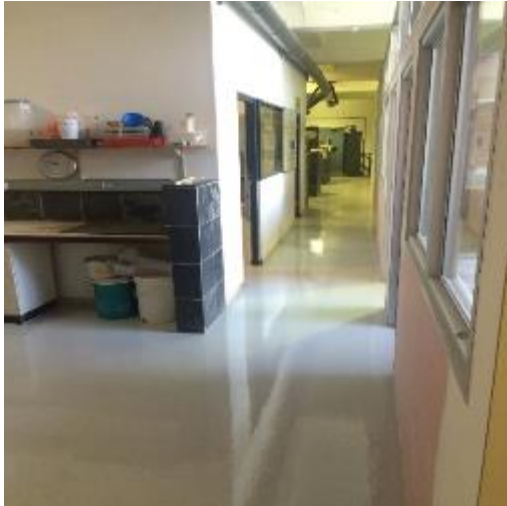
Figure 1: Laboratory Floors refurbished with epoxy coating.
