Building Portfolio

This document tracks the progress of the building and renovation of the Pollution Research Group in the basement of the Chemical Engineering Building at the University of KwaZulu-Natal. This document provides a regular update of the progress from the start of the alterations up to the date of completion.

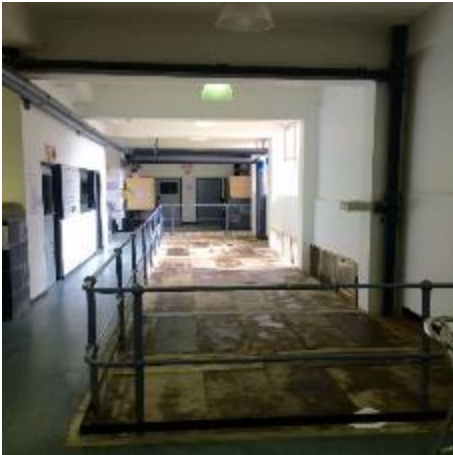
Figure 1: Basement 1 slab foundation.

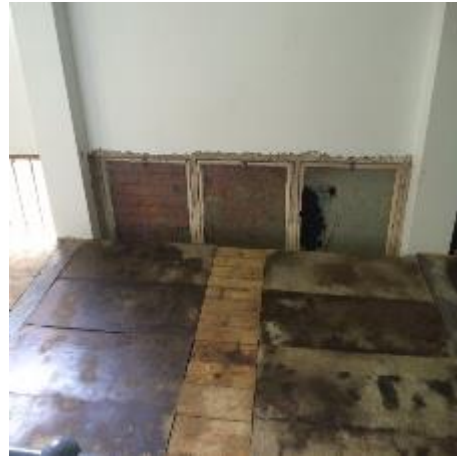
Figure 2: Windows behind the wall caused delays.

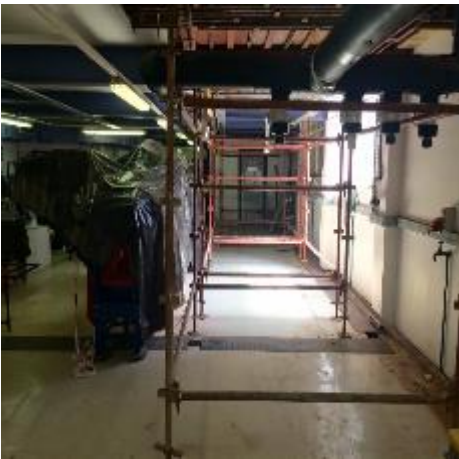
Figure 3: Basement 2 LaDePa region with scaffolding .

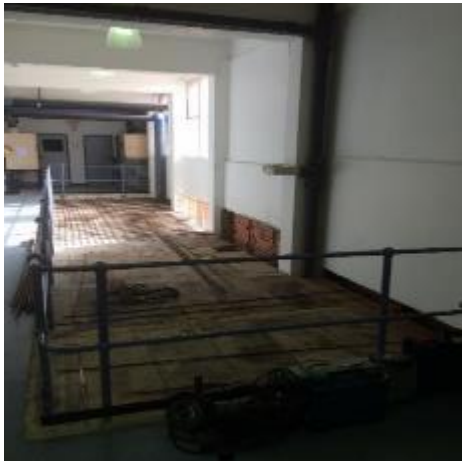
Figure 1: Basement 1 slab foundation with metal reinforcement layer.

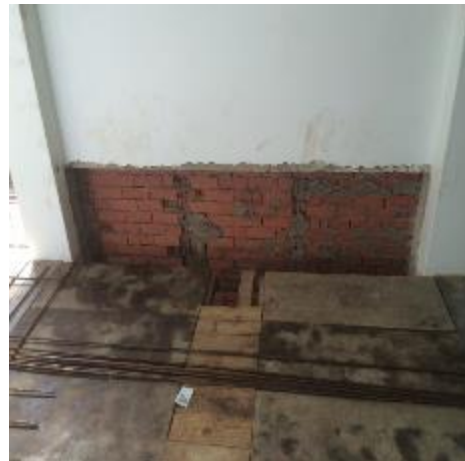
Figure 2: Windows panes removed.

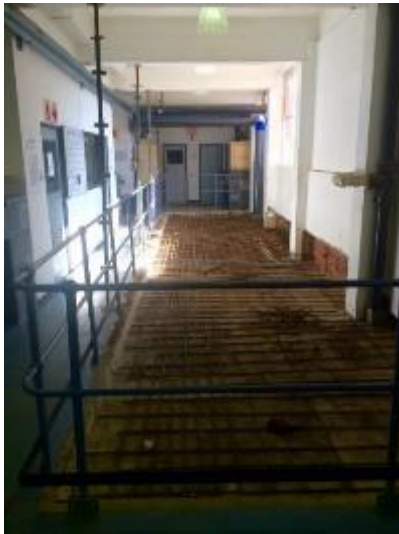
Figure 1: Basement 1 slab foundation with metal reinforcement grid.

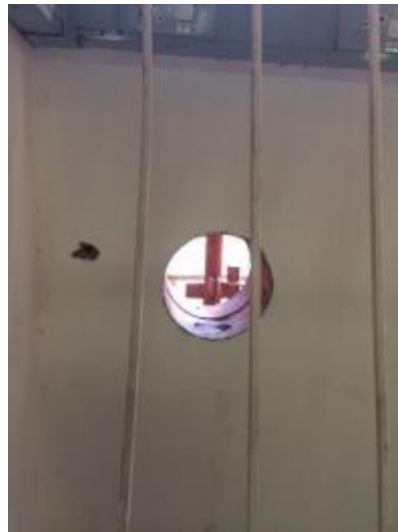
Figure 2: Hole made for the wash station.

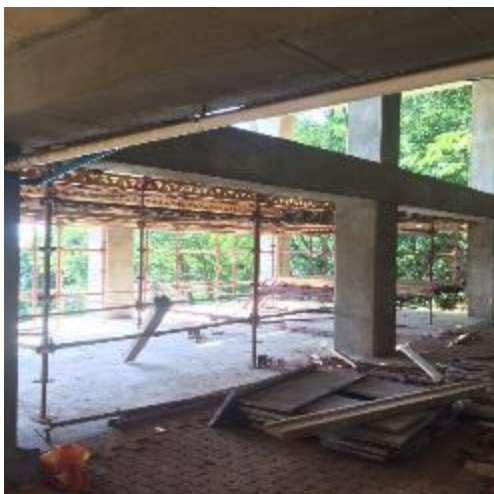
Figure 5: Gas cylinder storage area 1 with concrete foundation and scaffolding.

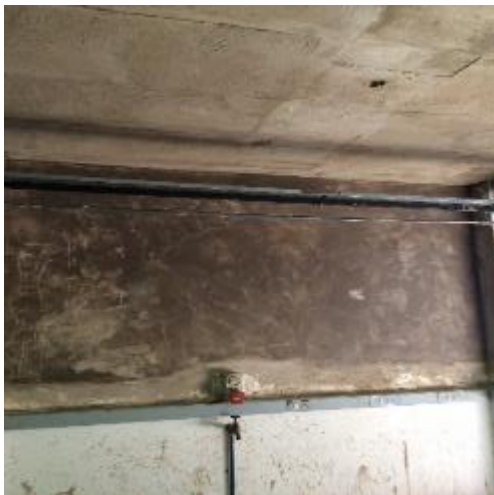
Figure 5: The window that was taken down and cause delays has been sealed.

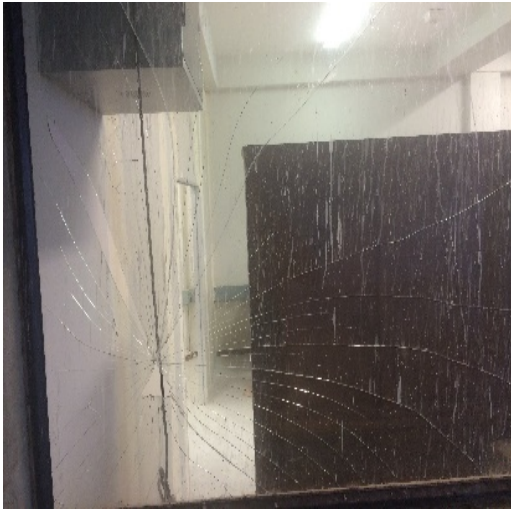
Figure 1: Damaged window between lab and office arera.

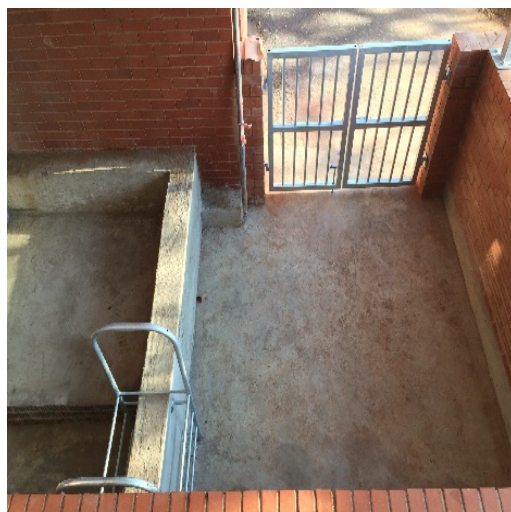
Figure 4.1: Wash station area completed. Gates and stairs to be changed.

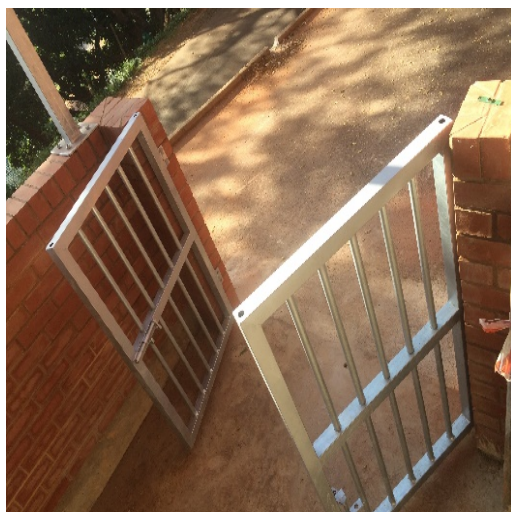
Figure 4.2: Problem encountered with the narrow gates fitted for the wash area.

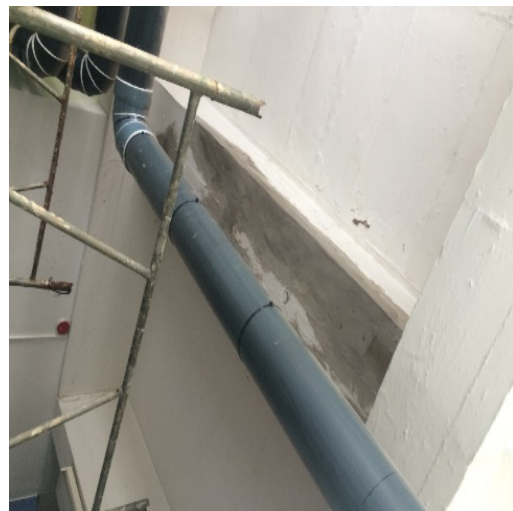
Figure 4: Beam spalding repaired

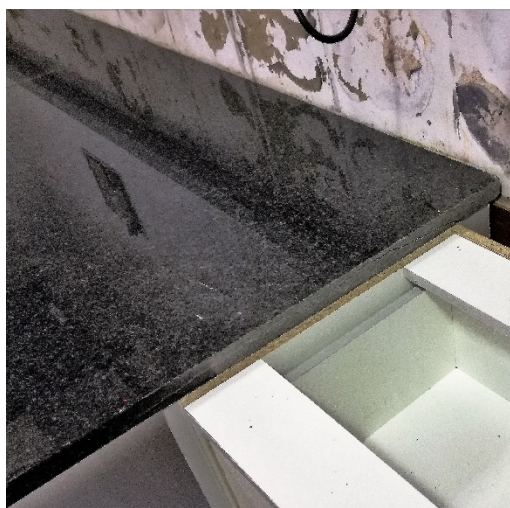
Figure 4.1: A crack on a fitted granite.

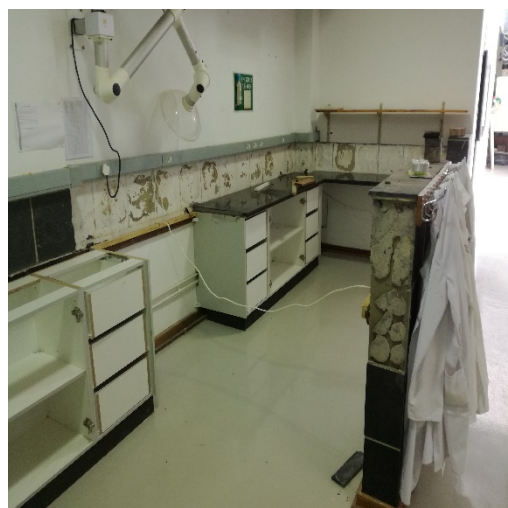
Figure 5: Cracked granite removed .

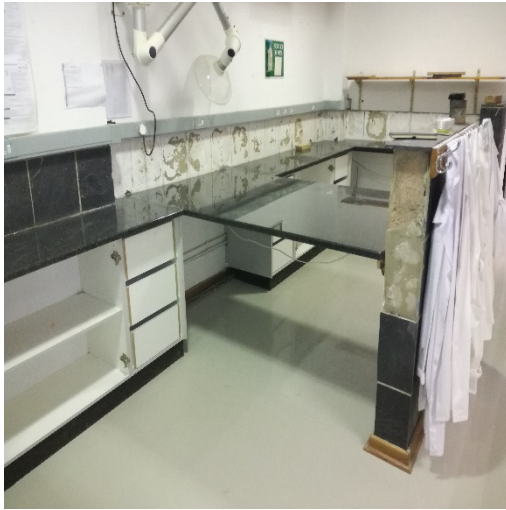
Figure 1: Island granite replaced, tiles removed without any authorization.
