This document will trace the progress of the building at the University of KwaZulu-Natal, Chemical Engineering Building, basement, Pollution Research Group. This document will be updated every week to keep track and progress of the building taking place and at large serve as the building portfolio.

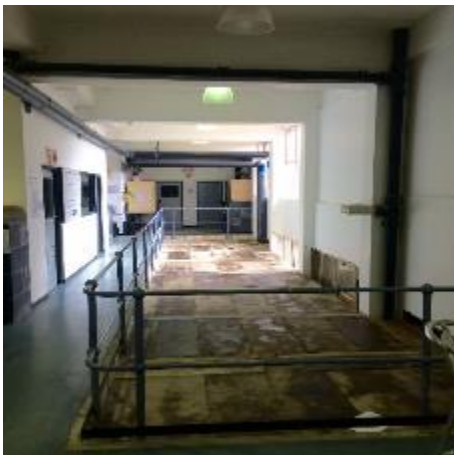
Figure 1: Basement 1 slab foundation.

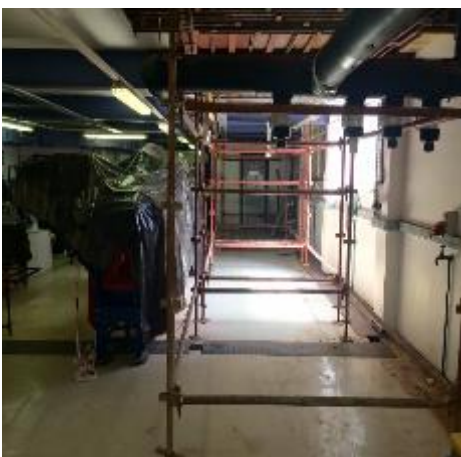
Figure 3: Basement 2 LaDePa region with scaffolding .

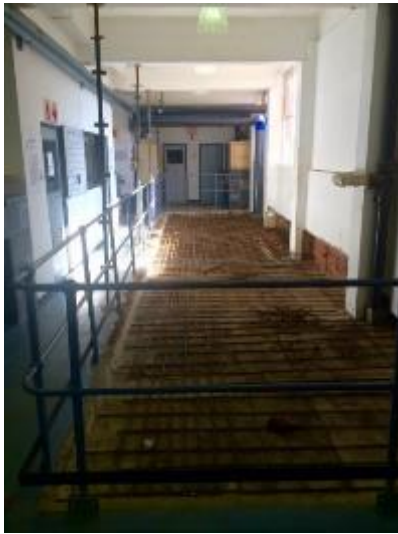
Figure 1: Basement 1 slab foundation with metal reinforcement grid.

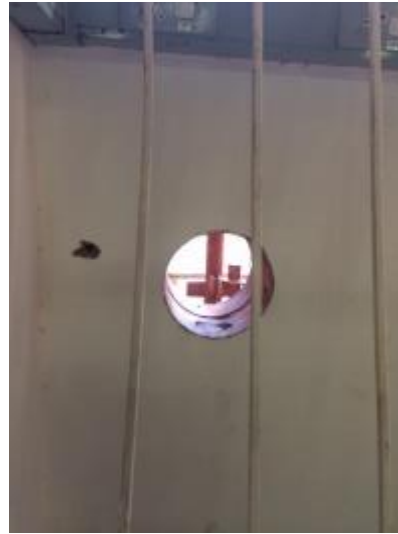
Figure 2: Hole made for the wash station.

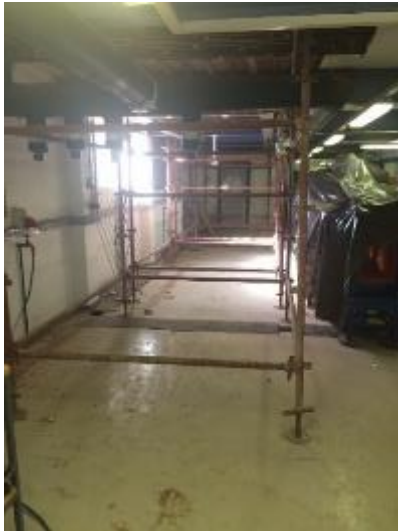
Figure 3: Basement 2 LaDePa region with scaffolding.

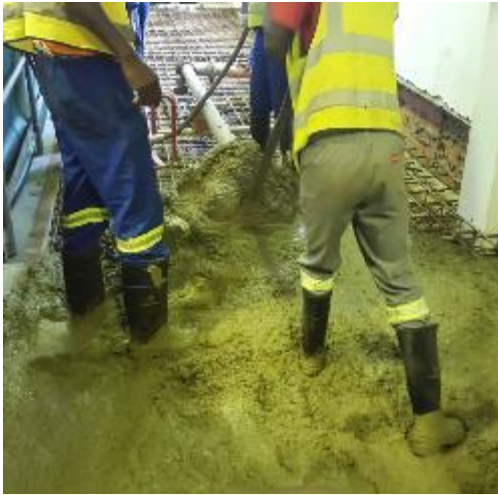
Figure 1: Cementing of Basement 1.

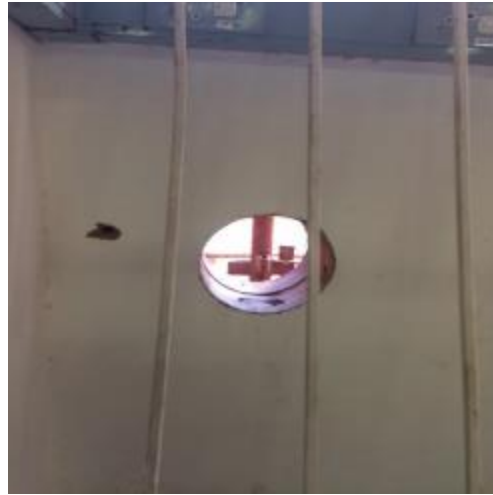
Figure 2: Hole made for wash station.

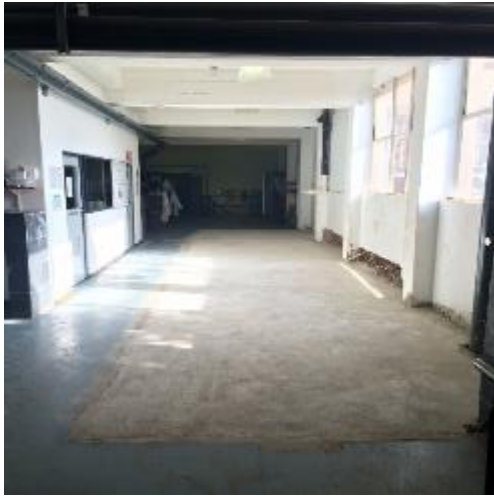
Figure 1: Basement 1 slab finished.

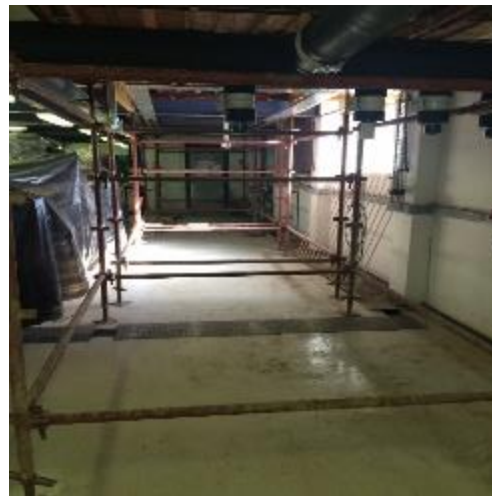
Figure 4: LaDepa region with scafflodng underneath the finished slab.

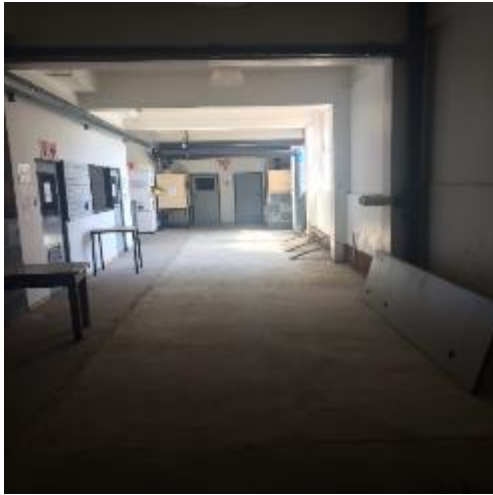
Figure 1: Basement 1 slab finished.

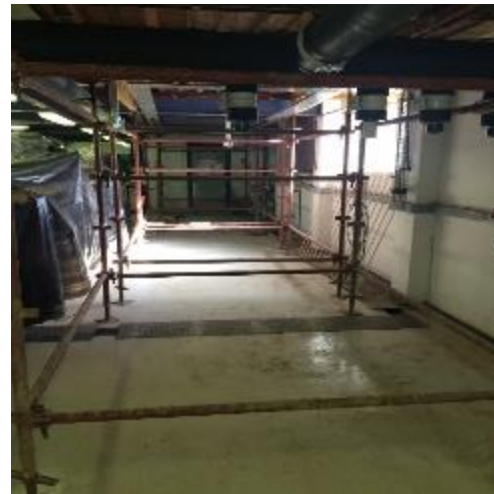
Figure 4: LaDepa region scaffolding underneath the finished slab.

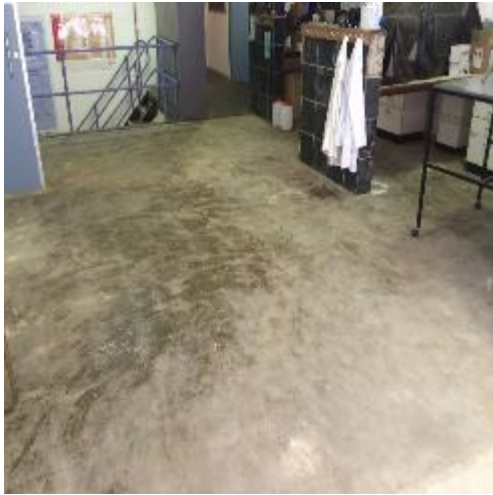
Figure 1: Basement 1 slab finished, tiles completely removed from the whole Basement 1 floor.

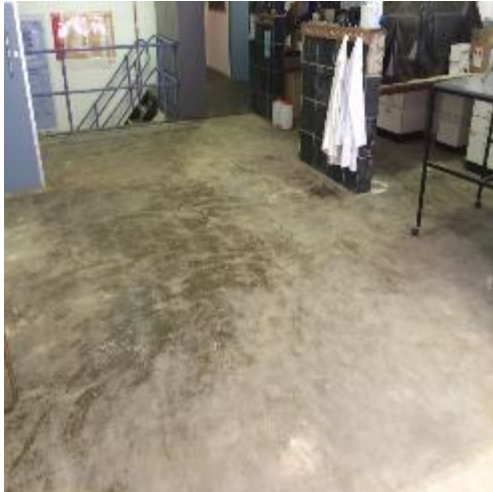
Figure 1: Basement 1 slab finished, tiles completely removed from the floor.

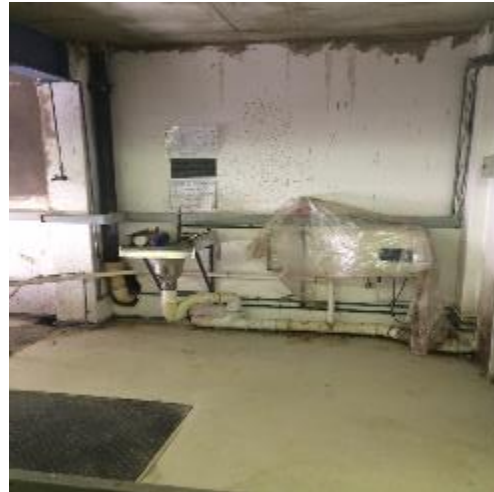
Figure 2: Sink area, scaffolding partially removed, coldroom is accessible.

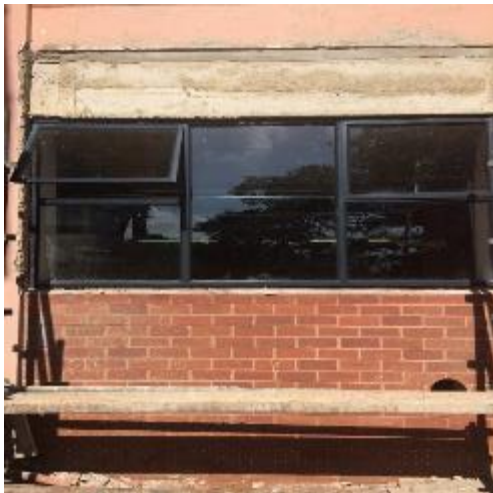
Figure 3: New window installed on the wash basin wall area (outside).

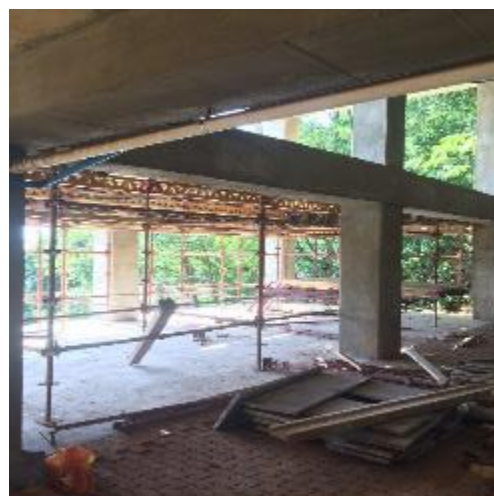
Figure 6: Gas cylinder storage area 1 with concrete foundation and scaffolding.

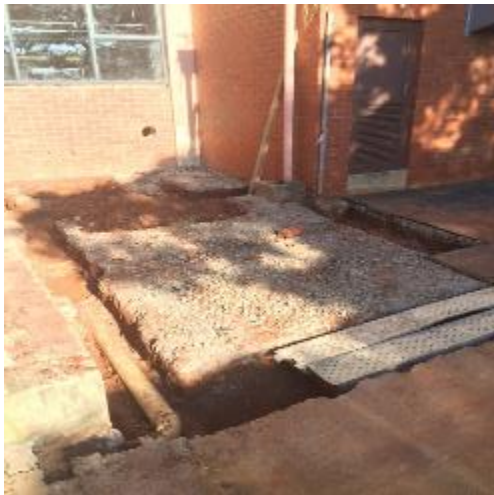
Figure 3: Wash station foundation preparation.

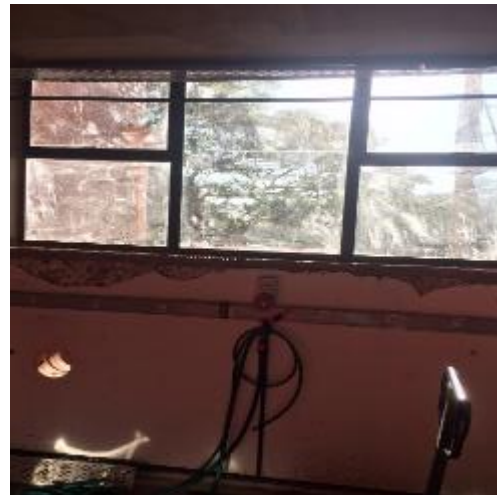
Figure 4: New window. LaDePa region (inside) and wash basin (outside).

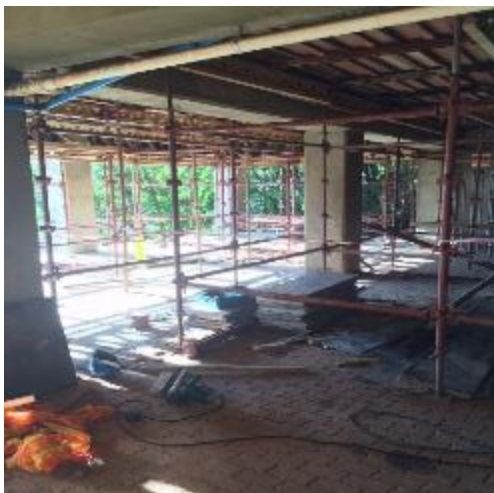
Figure 5: Gas cylinder storage area 1 with scaffolding

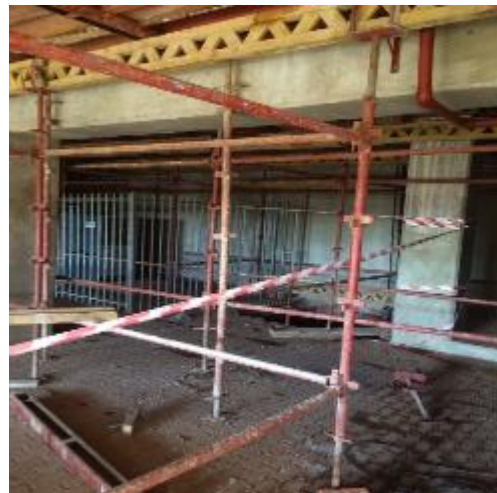
Figure 6: Gas cylinder storage area 2 with scaffolding spanning across area 1 and 2.

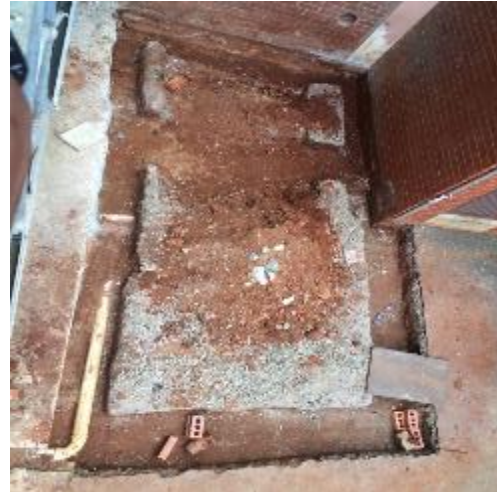
Figure 2: Wash station area, foundation further dug up.

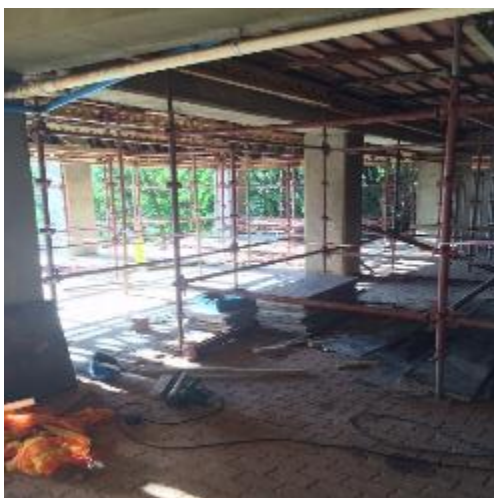
Figure 5: Gas cylinder storage area 1 with scaffolding.

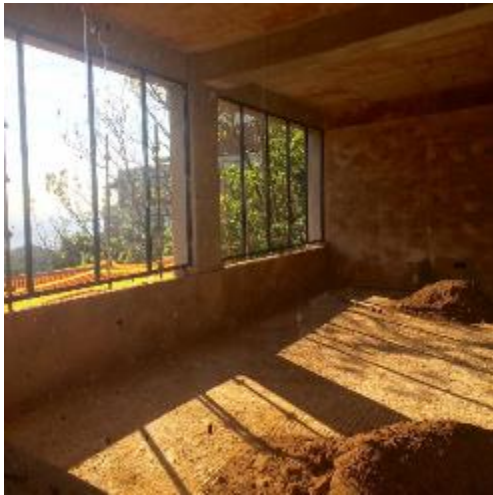
Figure 1: New office area with window frames installed, above gas cylinder storage area 1.
