This document aims to trace the progress of the building of the Pollution Research Group at the basement of Chemical Engineering Building, University of KwaZulu-Natal. This document will be updated regularly to keep track of the progress of the building alterations taking place.

29 January 2016

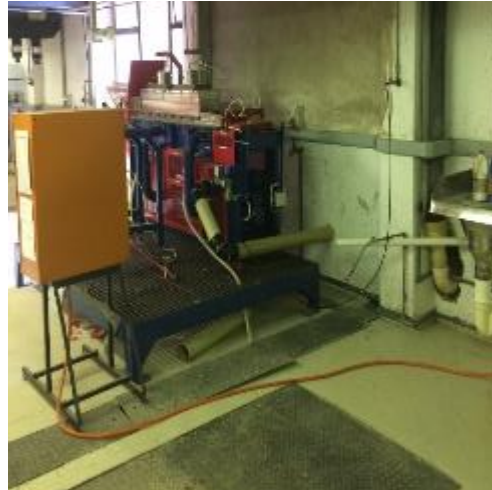
Figure 2: Coldroom is accessible and the ladepa is moved back into place.

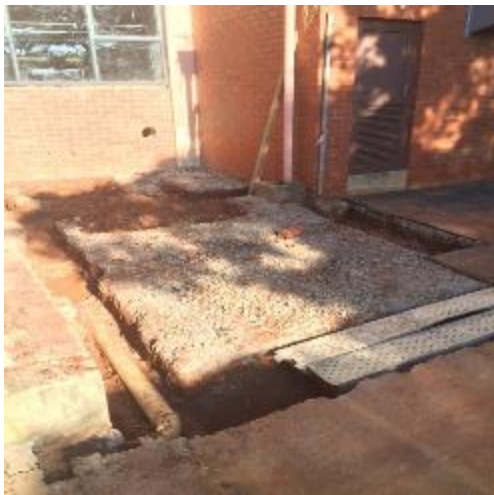
Figure 3: Wash station foundation preparation.

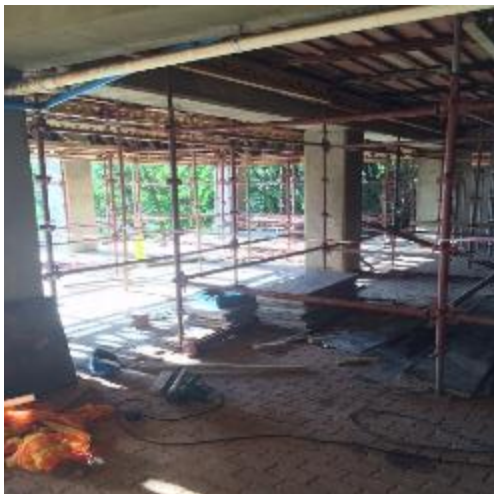
Figure 5: Gas cylinder storage area 1 with scaffolding

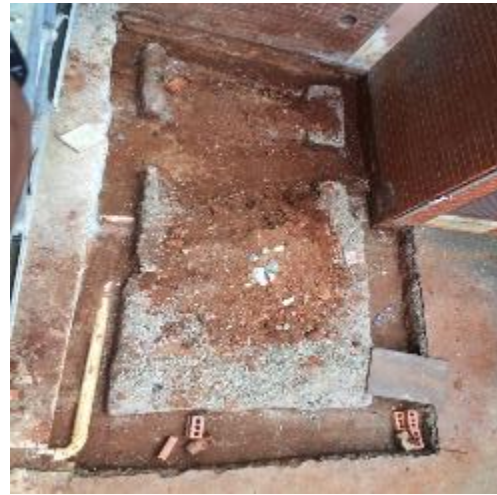
Figure 2: Wash station area, foundation further dug up.

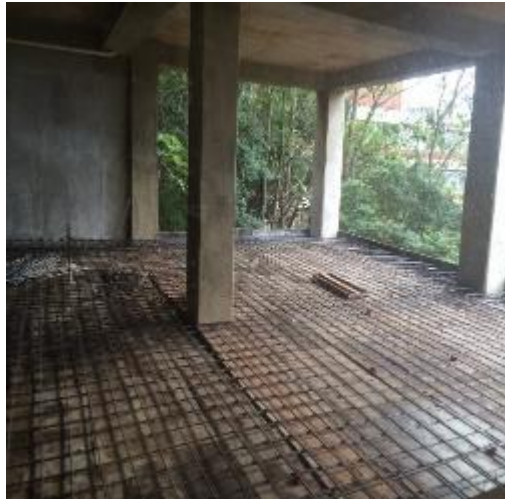
Figure 3: New slab foundation with grid layer (underpinning) View from the office window.

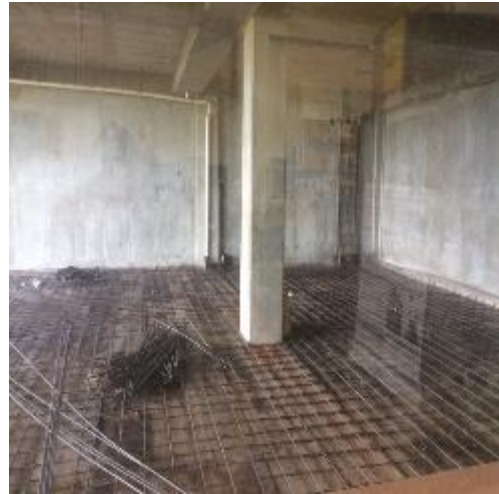
Figure 4: New slab foundation with grid layer (underpinning), above gas cylinder area 2.

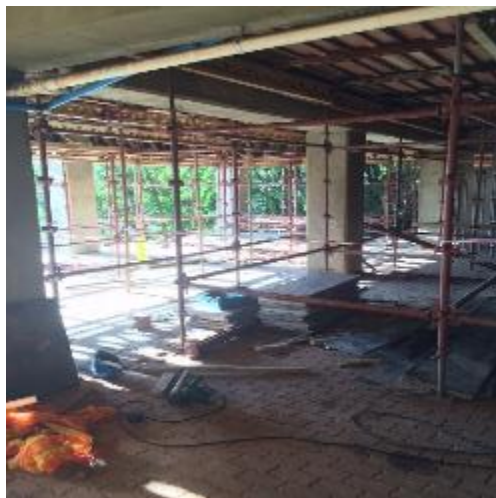
Figure 5: Gas cylinder storage area 1 with scaffolding.
20 May 2016

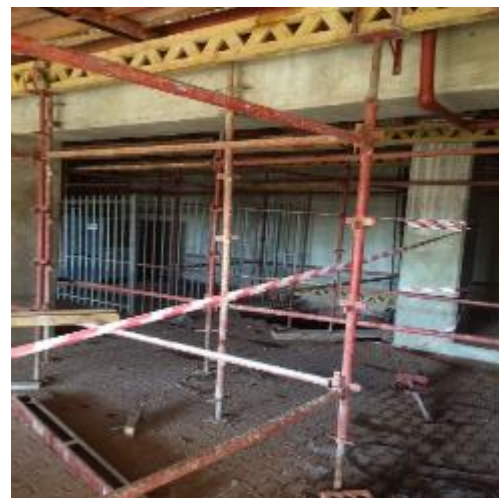
Figure 6: scaffolding spanning across the gas cylinder storage area 1 and area 2.

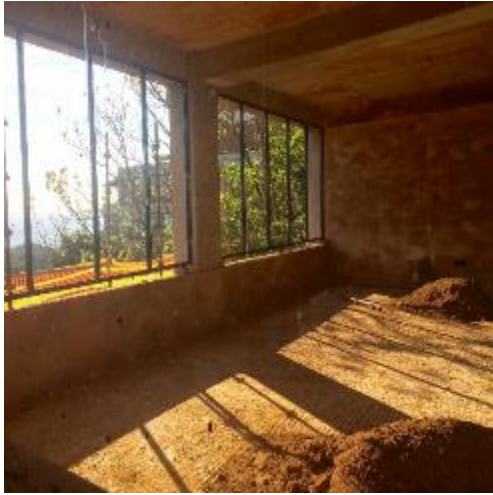
Figure 1: New office area with window frames installed, above gas cylinder storage area 1.

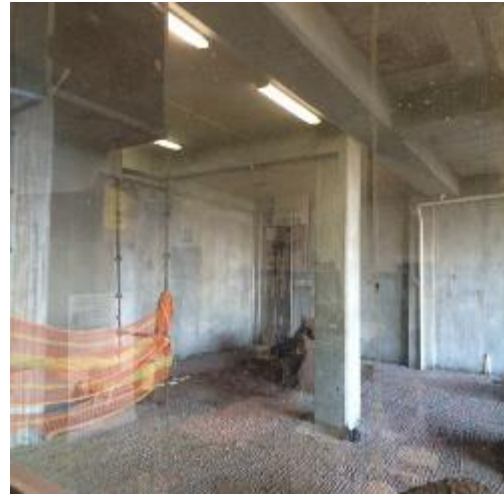
Figure 2: New office area closed up and plastered, above gas cylinder storage area 1.

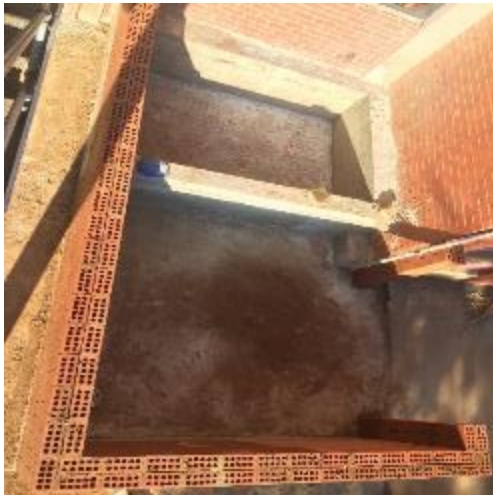
Figure 3: Wash station area.

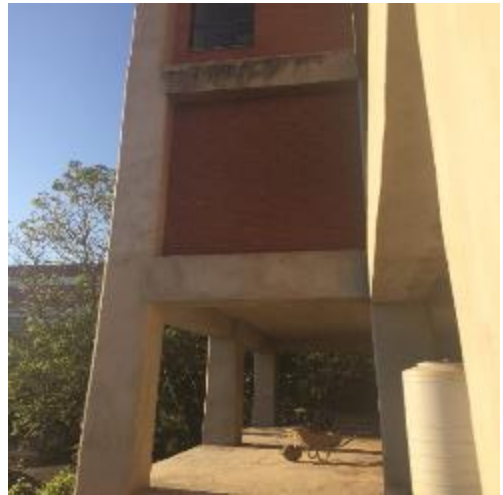
Figure 4: New office area sealed, outside view from PRG office entry.

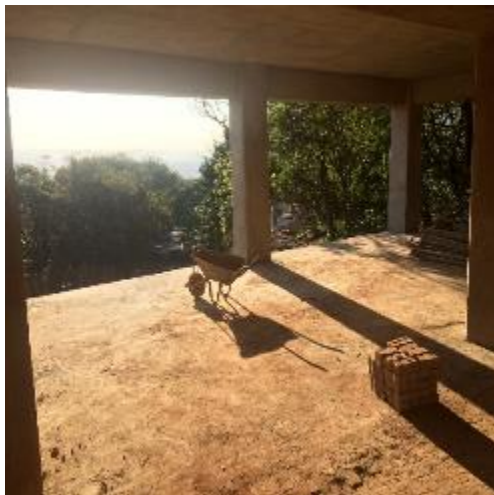
Figure 5: Gas cylinder storage area 1.

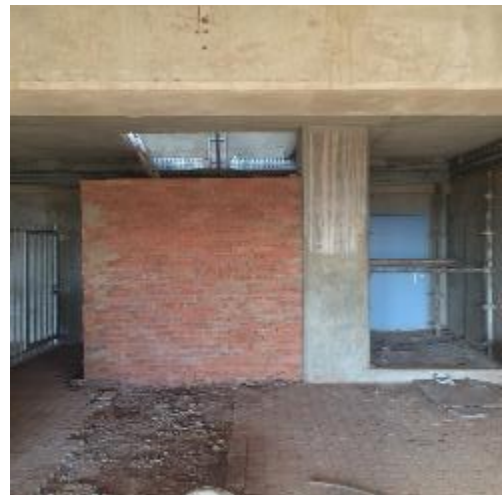
Figure 6: Gas cylinder storage area 2.

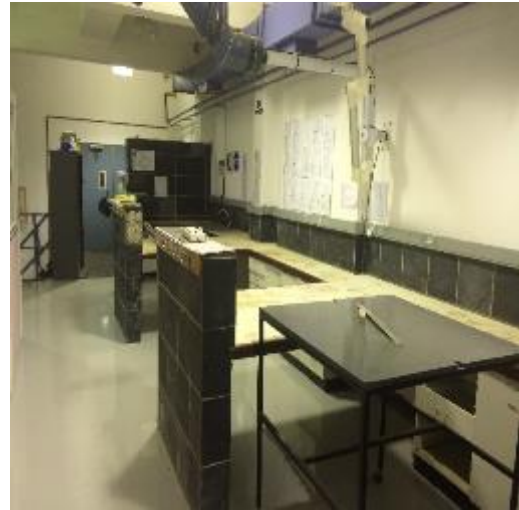
Figure 2: Laboratory work benchtops cleared of equipment, to be refurbished.

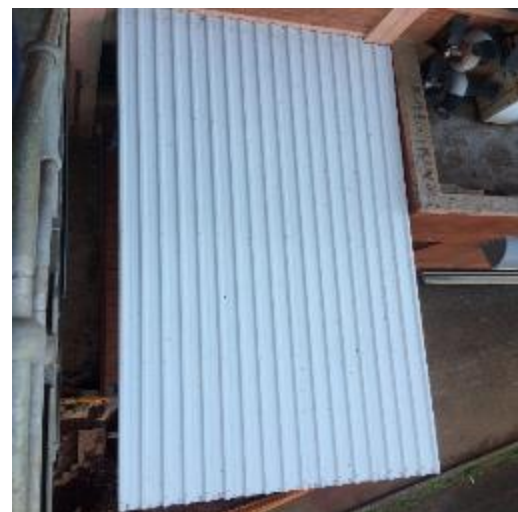
Figure 6: Gas cylinder storage area 2.
