Building Portfolio

This document tracks the progress of the building and renovation of the Pollution Research Group in the basement of the Chemical Engineering Building at the University of KwaZulu-Natal. This document provides a regular update of the progress from the start of the alterations up to the date of completion.

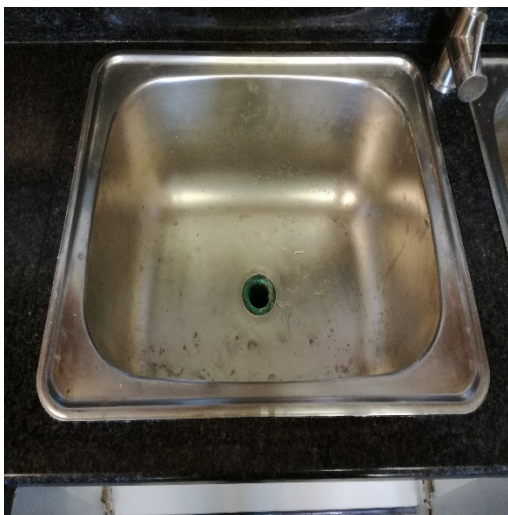
Figure 4.1: Sinks fitted properly after granite adjustment.
