This document will trace the progress of the building at the University of KwaZulu-Natal, Chemical Engineering Building, basement, Pollution Research Group. This document will be updated every week to keep track and progress of the building taking place and at large serve as the building portfolio.

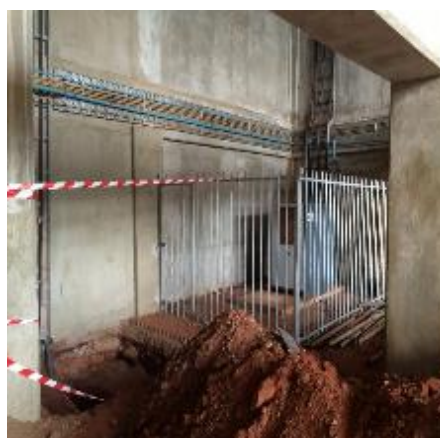
Figure 6: Gas cylinder storage area 2.

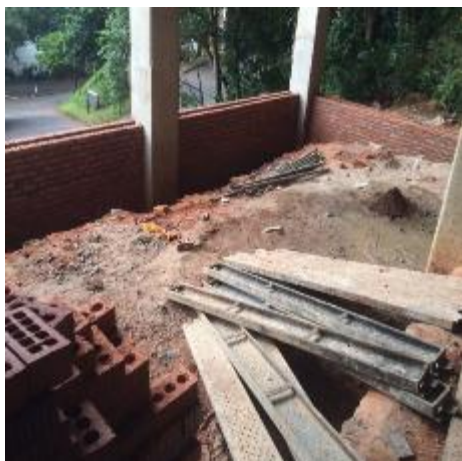
Figure 5: Gas cylinder storage area 1.

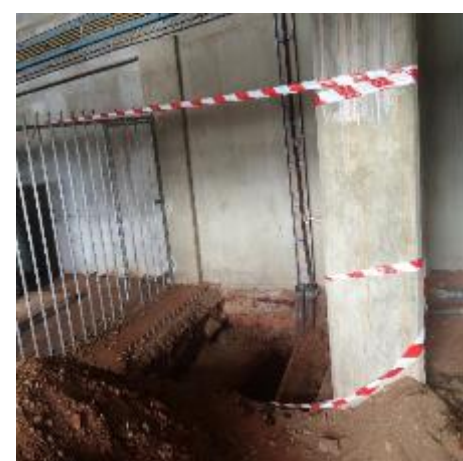
Figure 6: Gas cylinder storage area 2.

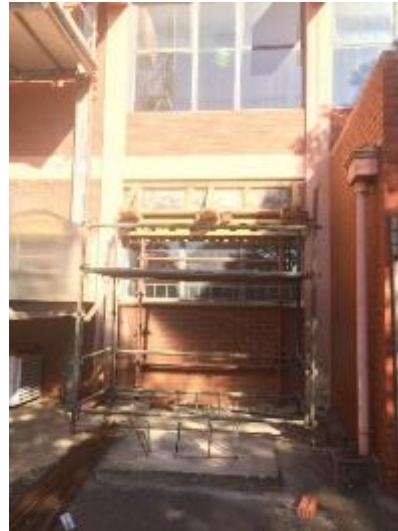
Figure 4: Wash station with hole and scaffolding staging and filters removed.

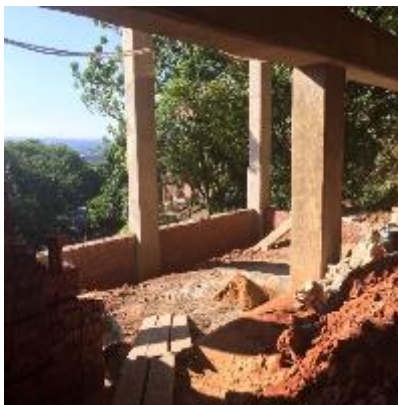
Figure 5: Gas cylinder storage area 1.

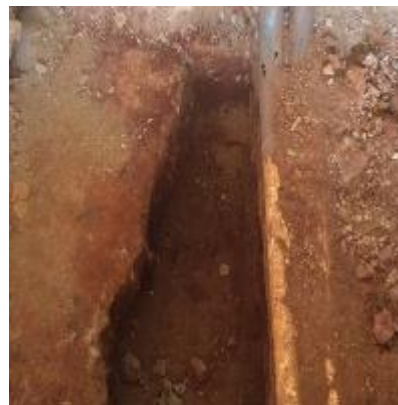
Figure 6: Gas cylinder storage area 2.

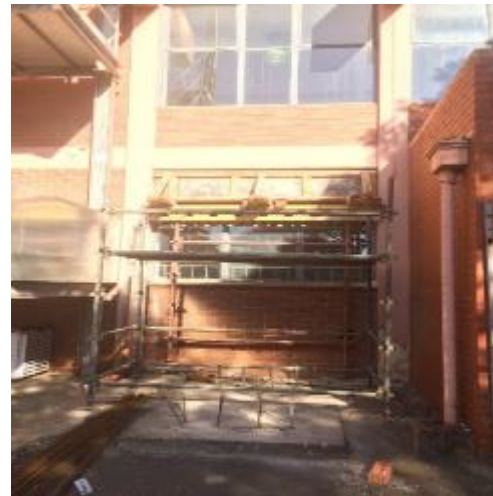
Figure 4: Wash station with hole and scaffolding staging.

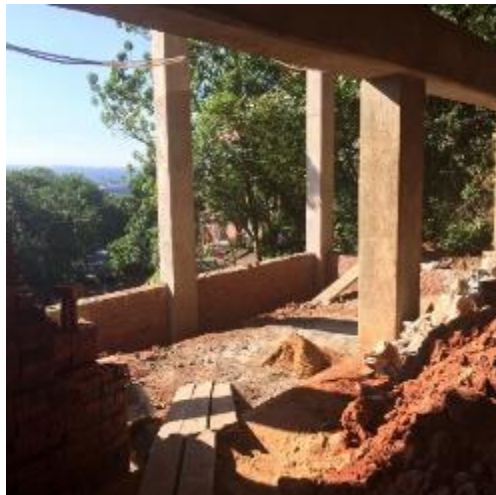
Figure 5: Gas cylinder storage area 1.

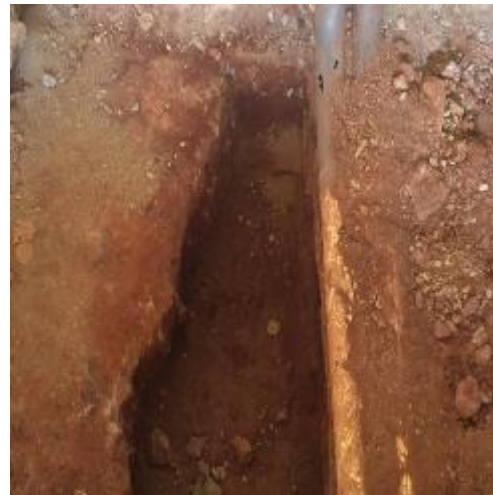
Figure 6: Gas cylinder storage area 2.

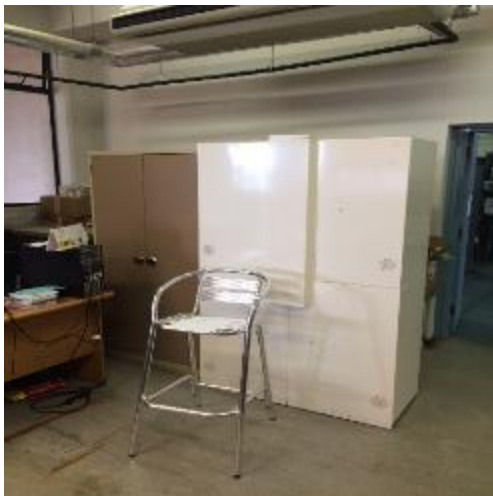
Figure 3: All labotary consumables and some equipment are currently in the office are.

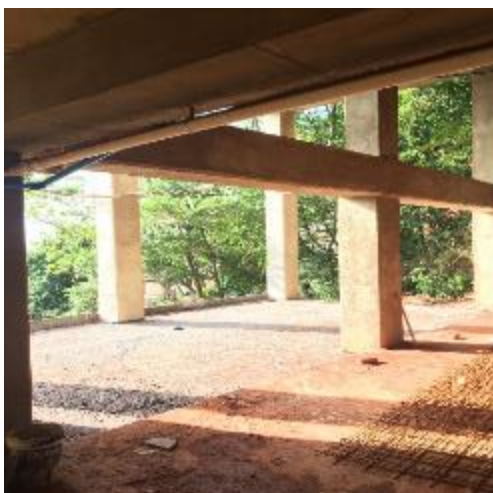
Figure 5: Gas cylinder storage area 1.

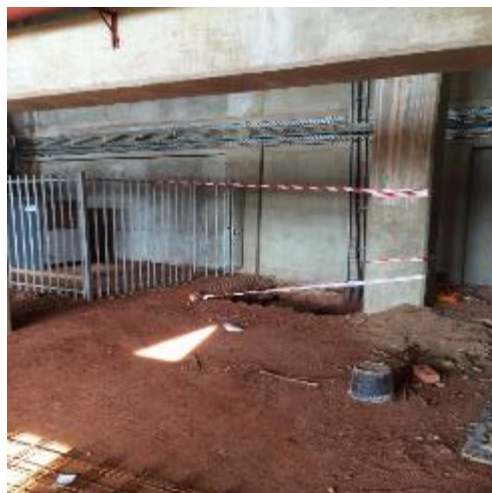
Figure 6: Gas cylinder storage area 2.

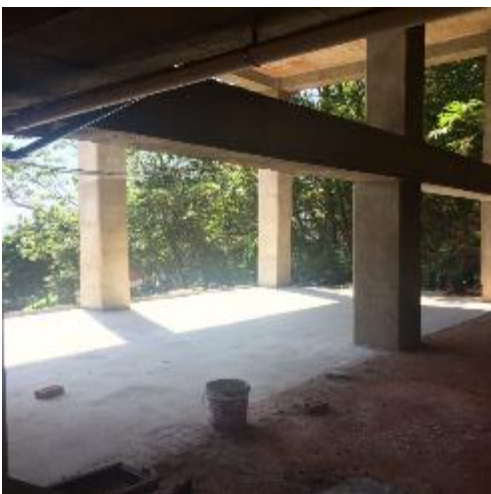
Figure 5: Gas cylinder storage area 1.

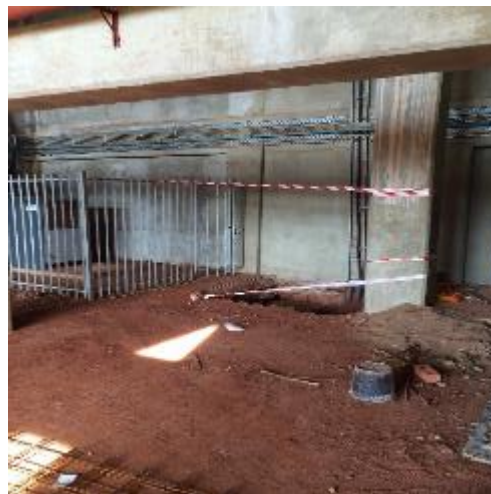
Figure 6: Gas cylinder storage area 2.

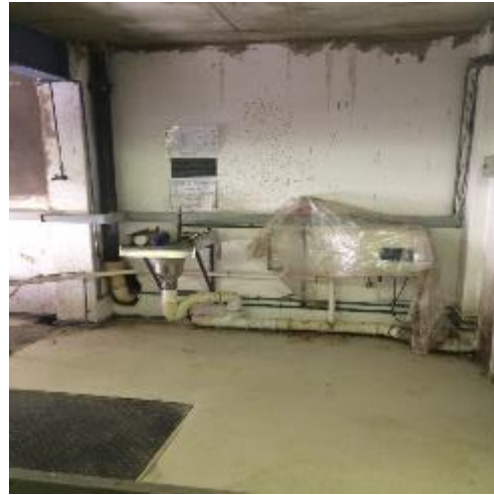
Figure 2: LaDepa region scaffolding partially removed, coldroom is accessible.

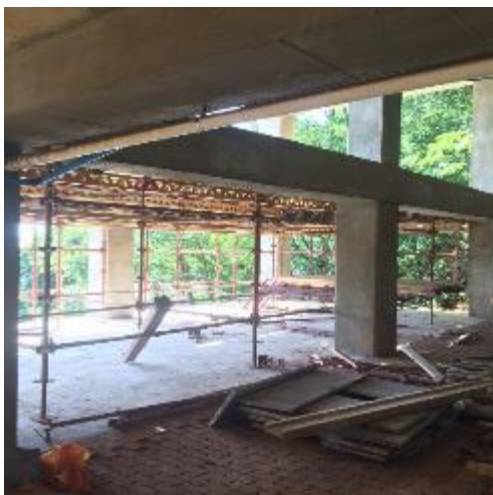
Figure 5: Gas cylinder storage area 1 with concrete foundation and scaffolding.

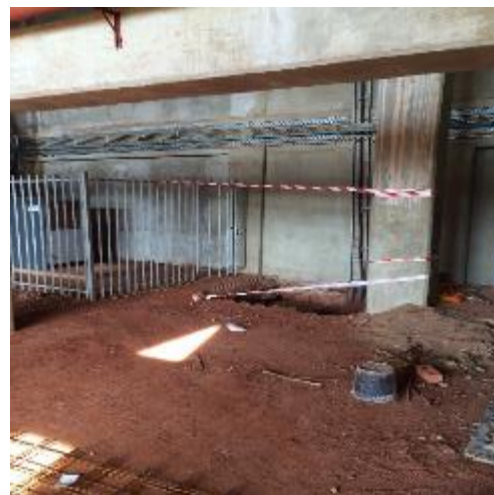
Figure 6: Gas cylinder storage area 2.

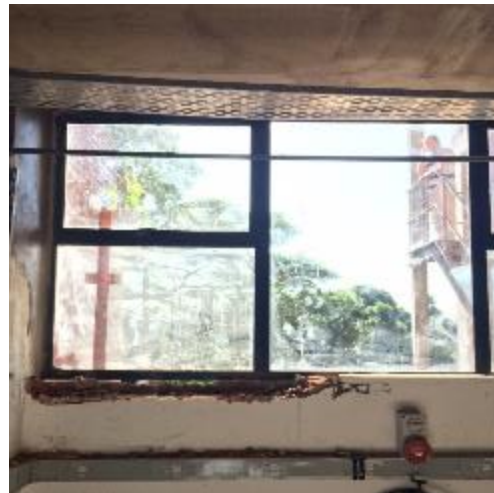
Figure 4: New window installed on the LaDePa area, view from the inside.

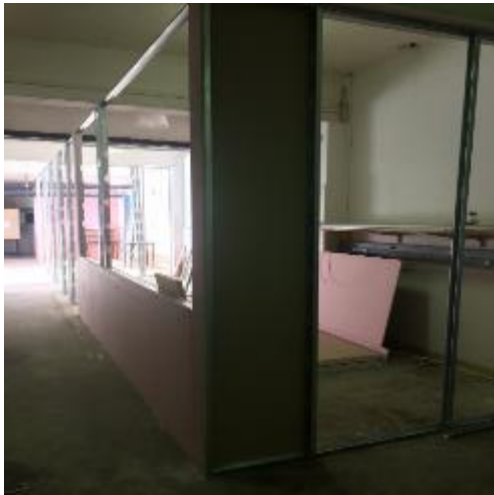
Figure 1: Partitioning of the lab.

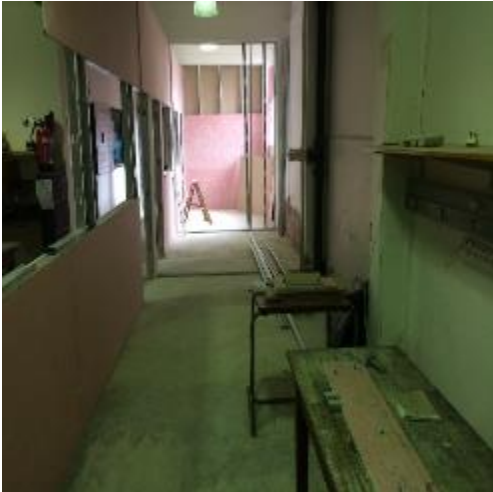
Figure 1: Partitioning of the lab.

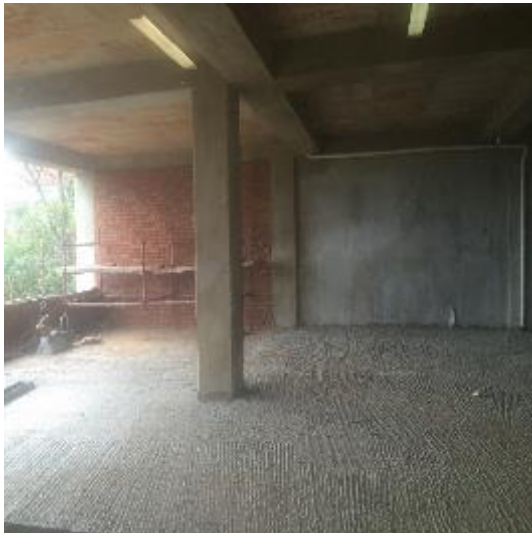
Figure 3: Slab layer completed outside the office area, above gas cylinder storage area 1.

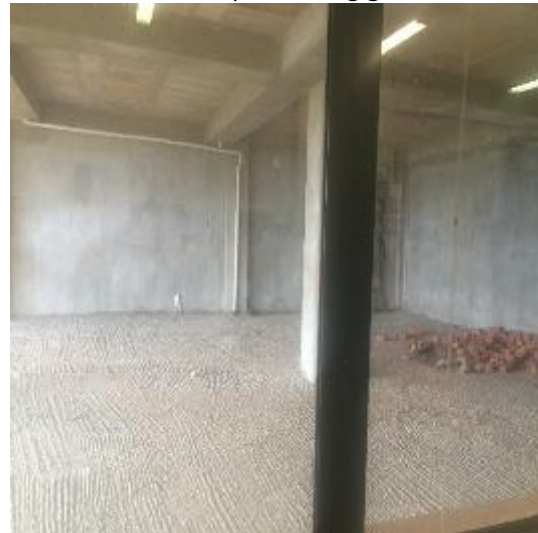
Figure 4: Slab layer completed outside the office area, above gas cylinder storage area 1.

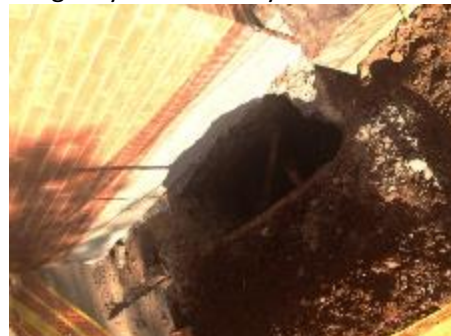
Digging (excavations) outside the wash area and emergency exit stairway.

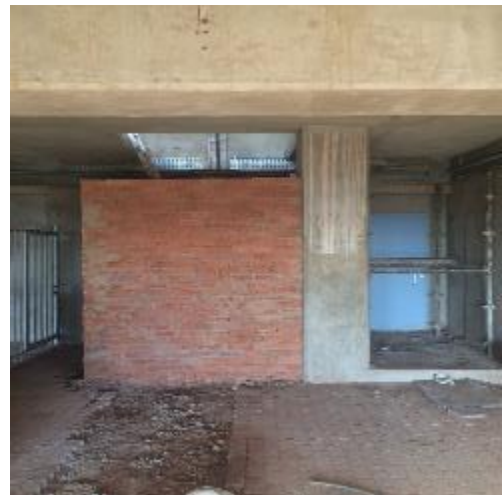
Figure 6: Gas cylinder storage area 2.
