This document aims to trace the progress of the building of the Pollution Research Group at the basement of Chemical Engineering Building, University of KwaZulu-Natal. This document will be updated regularly to keep track of the progress of the building alterations taking place.

29 January 2016

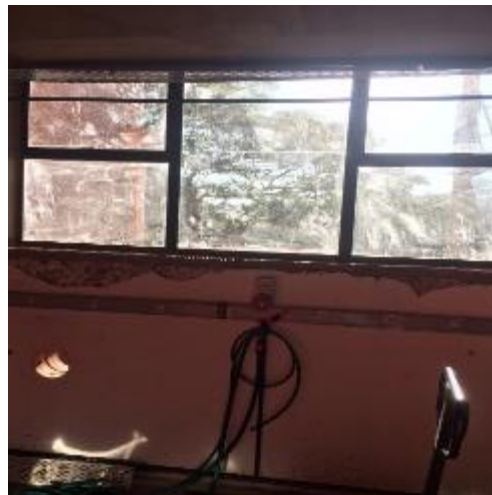
Figure 4: New window. LaDePa region (inside) and wash basin (outside).

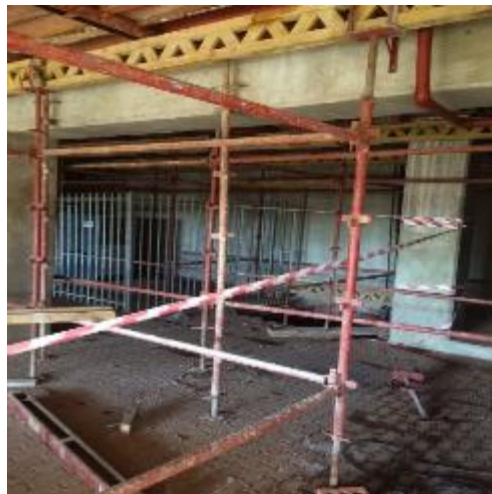
Figure 6: Gas cylinder storage area 2 with scaffolding spanning across area 1 and 2.

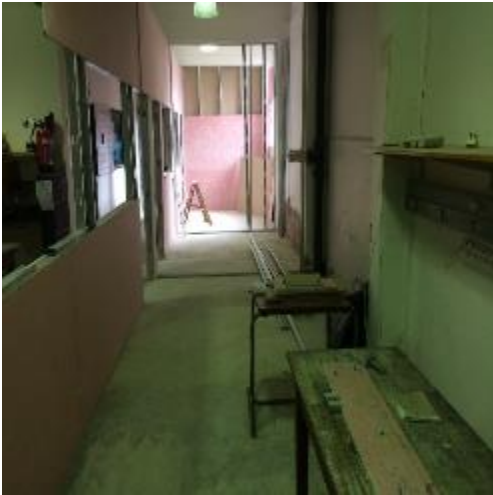
Figure 1: Partitioning of the lab.

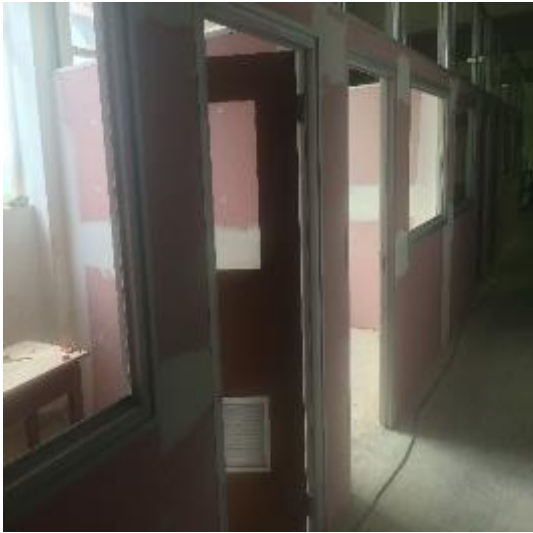
Figure 1: Lab partitioning, doors and window frames installed.

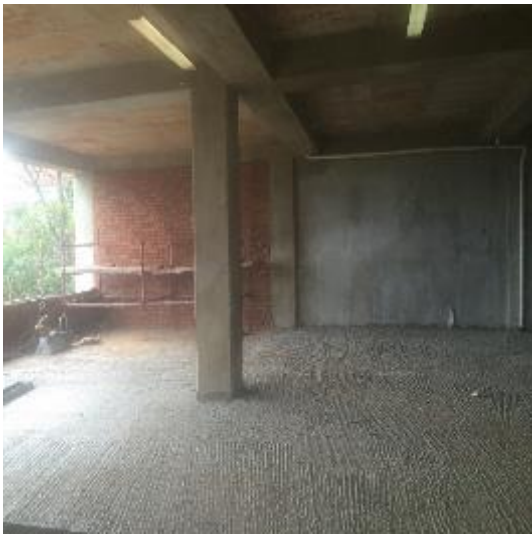
Figure 3: Slab layer completed outside the office area, above gas cylinder storage area 1.

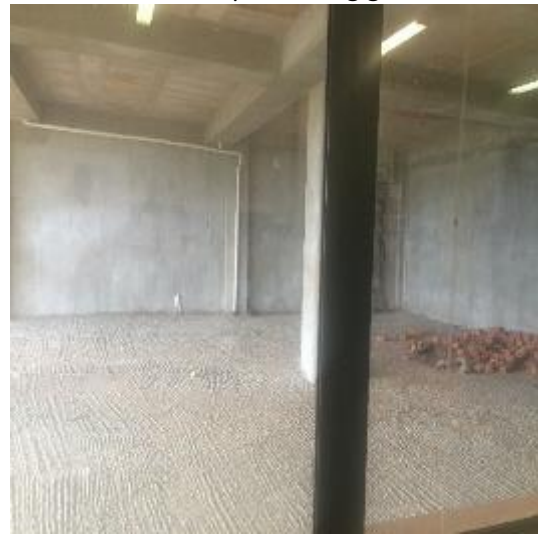
Figure 4: Slab layer completed outside the office area, above gas cylinder storage area 1.

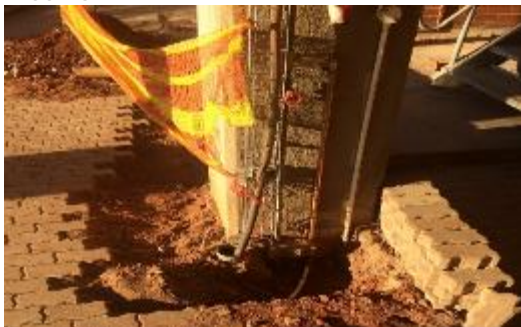
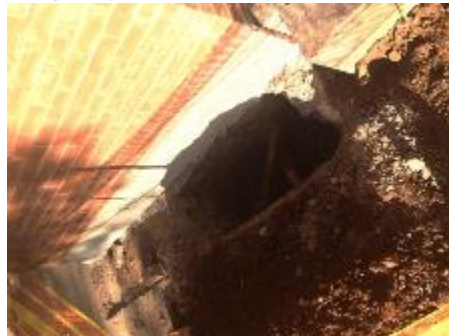
Digging (excavations) outside the wash area and emergency exit stairway.
