Building Portfolio

This document tracks the progress of the building and renovation of the Pollution Research Group in the basement of the Chemical Engineering Building at the University of KwaZulu-Natal. This document provides a regular update of the progress from the start of the alterations up to the date of completion.

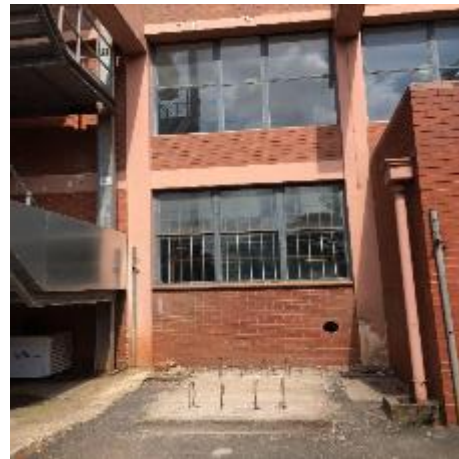
Figure 4: Wash station with drilled hole and filters removed.

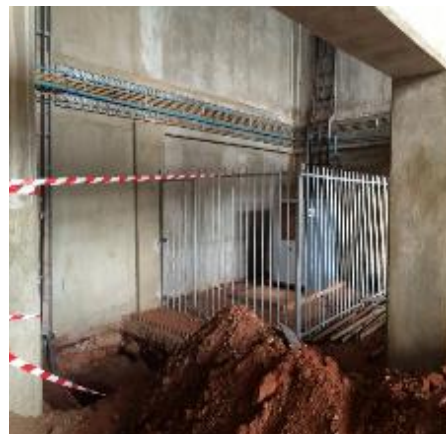
Figure 6: Gas cylinder storage area 2.

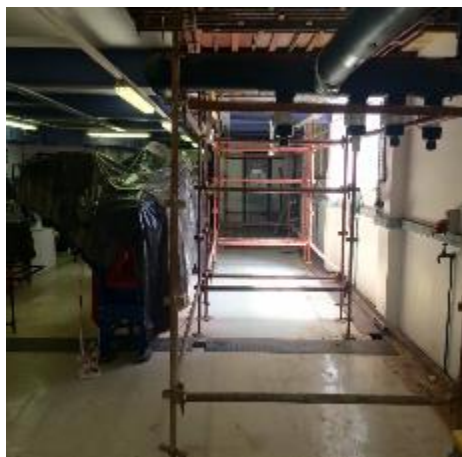
Figure 3: Basement 2 LaDePa region with scaffolding.

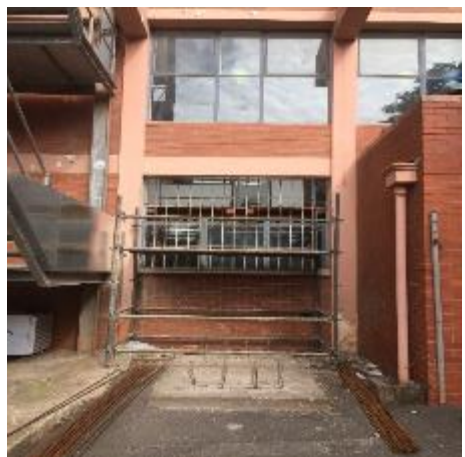
Figure 4: Wash station with hole and scaffolding staging and filters removed.

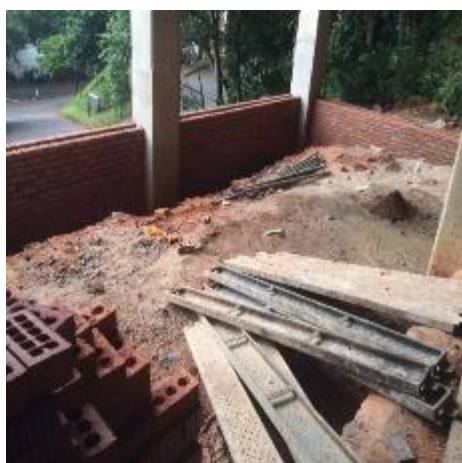
Figure 5: Gas cylinder storage area 1.

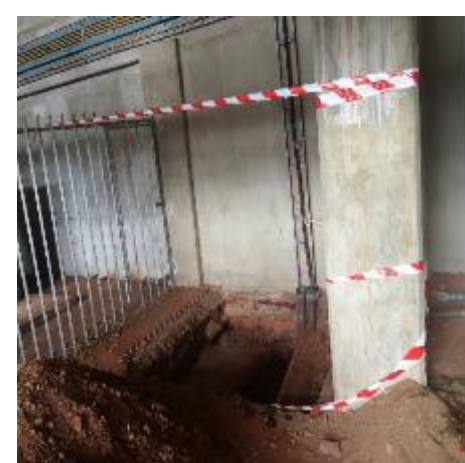
Figure 6: Gas cylinder storage area 2.

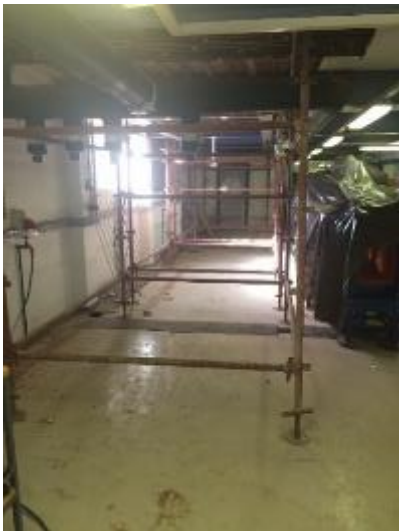
Figure 3: Basement 2 LaDePa region with scaffolding.

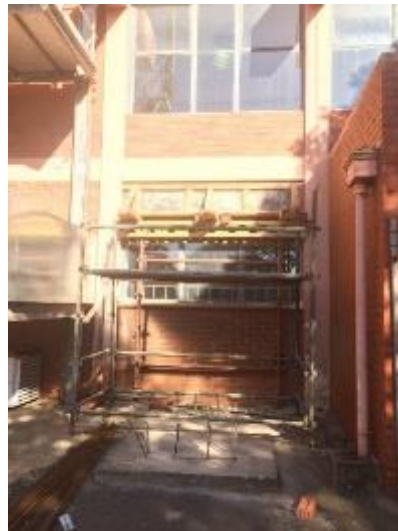
Figure 4: Wash station with hole and scaffolding staging and filters removed.

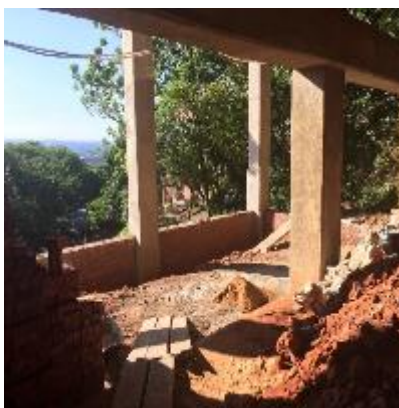
Figure 5: Gas cylinder storage area 1.

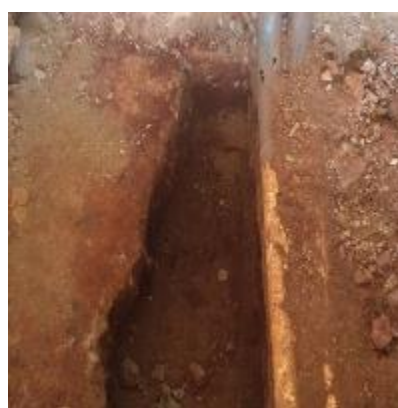
Figure 6: Gas cylinder storage area 2.

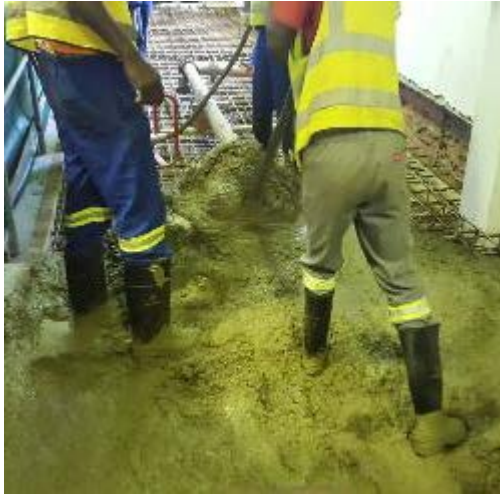
Figure 1: Cementing of Basement 1.

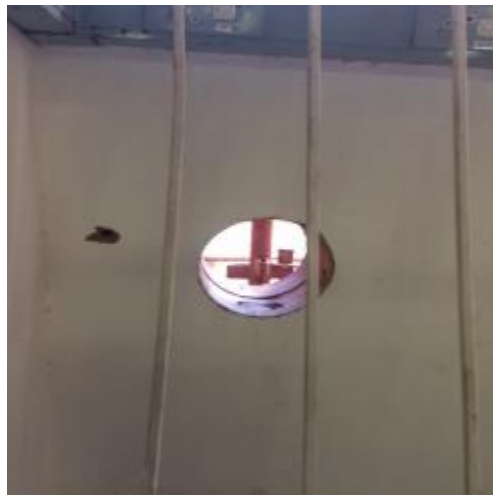
Figure 2: Hole made for wash station.

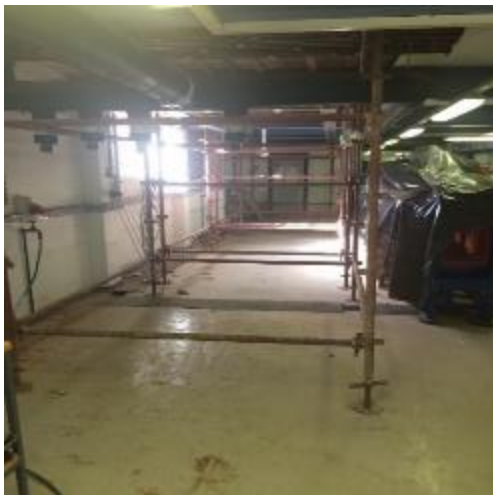
Figure 3: Basement 2 LaDePa region with scaffolding.

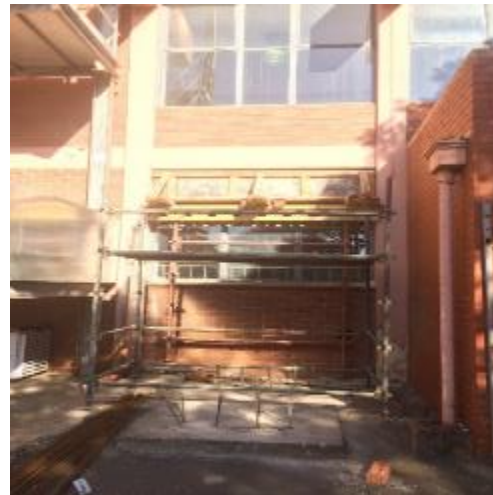
Figure 4: Wash station with hole and scaffolding staging.

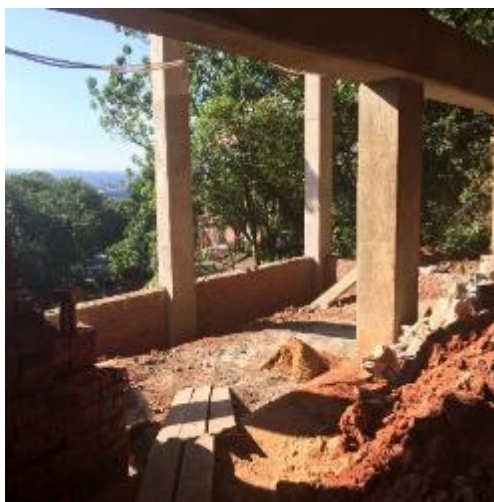
Figure 5: Gas cylinder storage area 1.

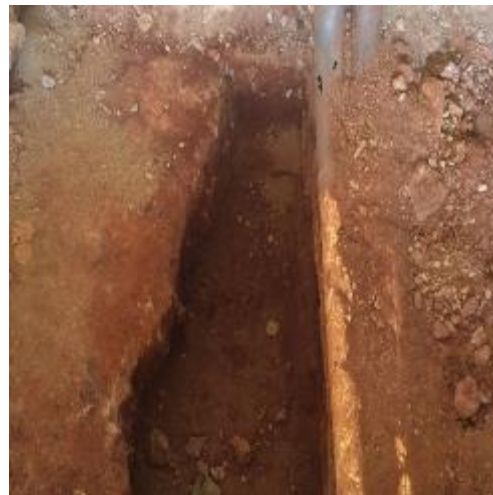
Figure 6: Gas cylinder storage area 2.

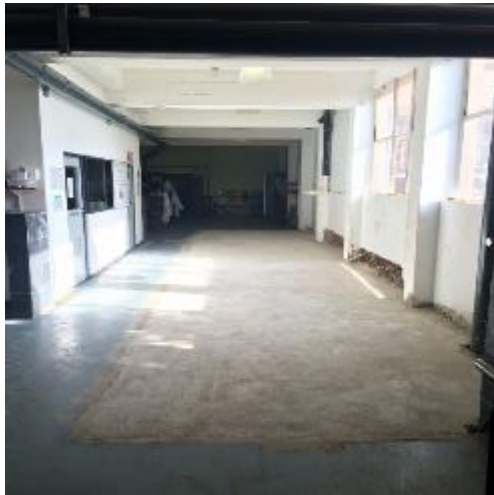
Figure 1: Basement 1 slab finished.

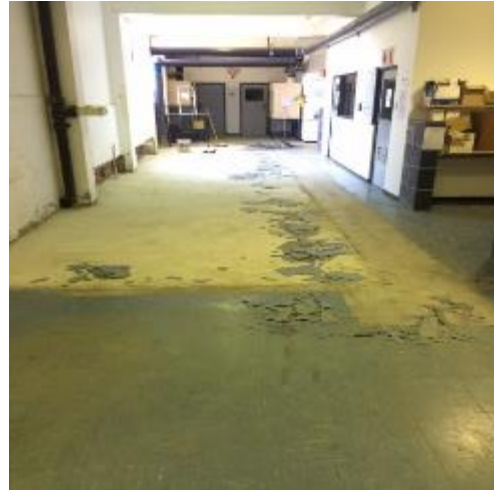
Figure 2: Removal of tiles in basement 1.

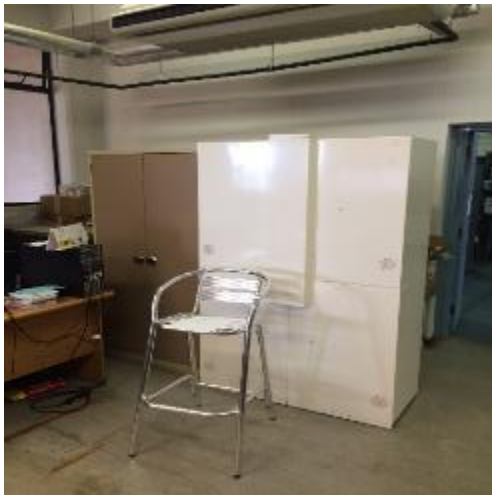
Figure 3: All labortary consumables and some equipment are currently in the office are.

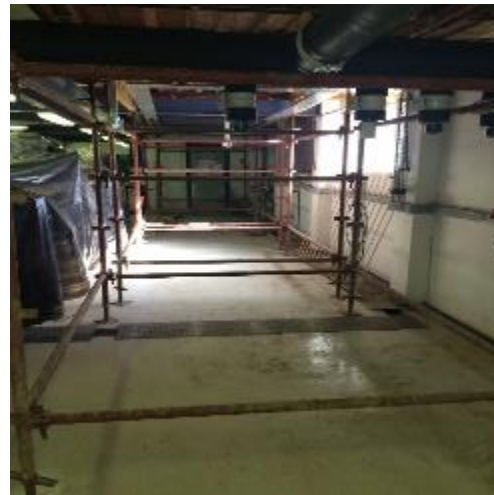
Figure 4: LaDepa region with scaffloding underneath the finished slab.

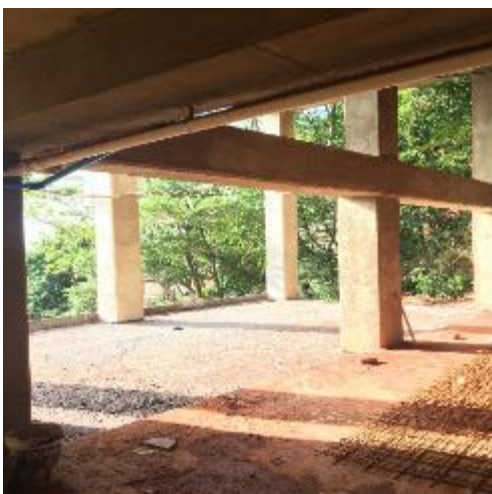
Figure 5: Gas cylinder storage area 1.

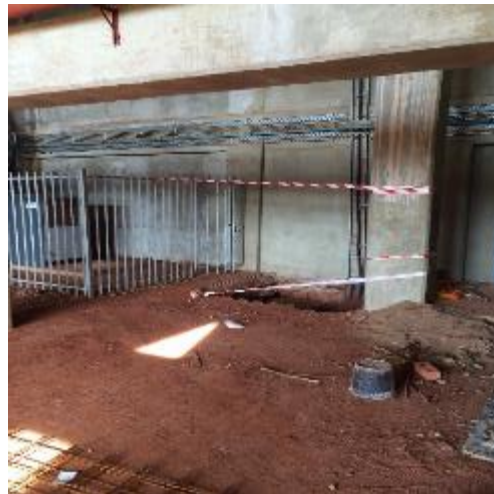
Figure 6: Gas cylinder storage area 2.

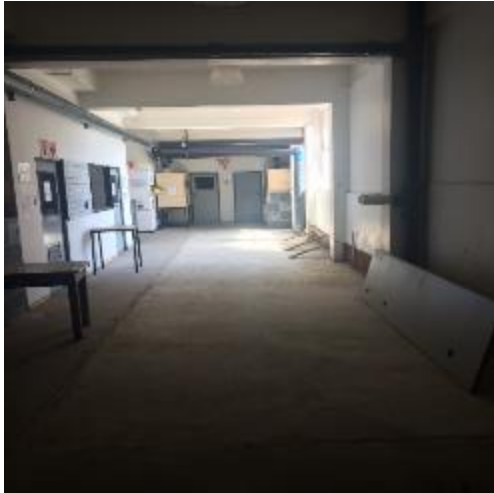
Figure 1: Basement 1 slab finished.

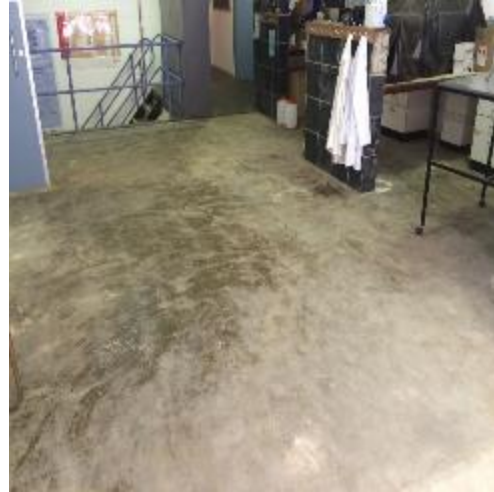
Figure 2: Tiles in Basement 1 completely removed on the floor.

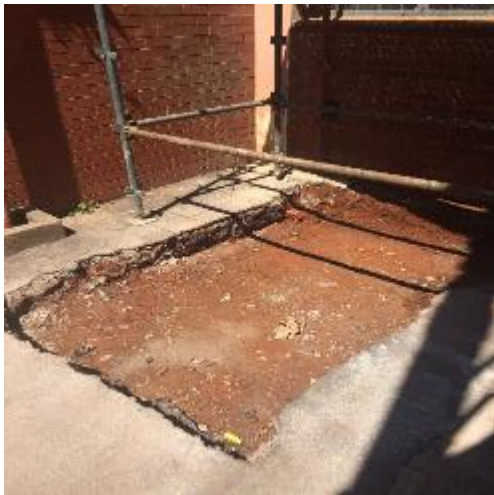
Figure 3: Concrete removed for the wash basin area.

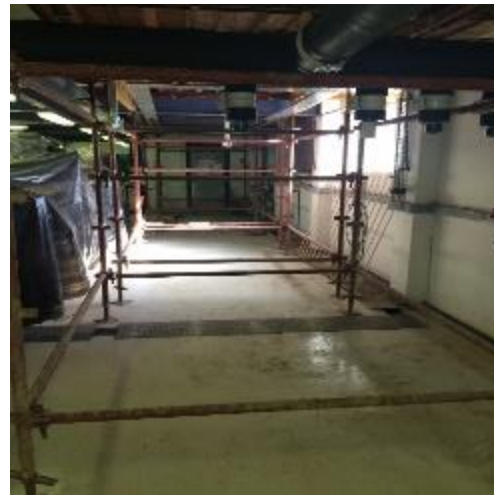
Figure 4: LaDepa region scaffolding underneath the finished slab.

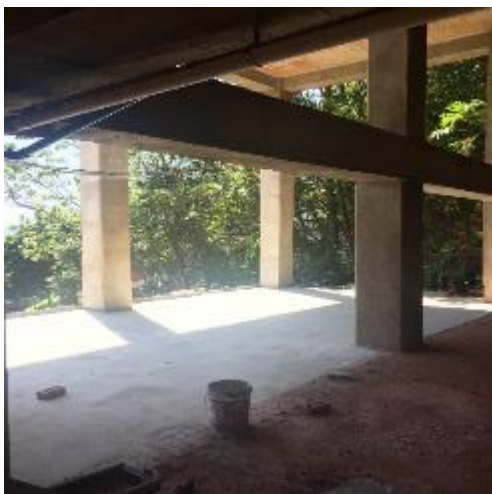
Figure 5: Gas cylinder storage area 1.

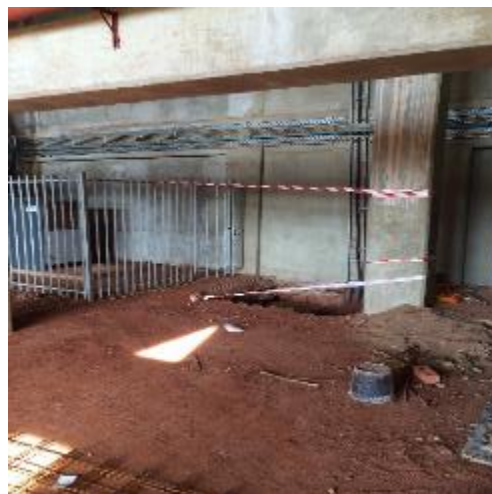
Figure 6: Gas cylinder storage area 2.

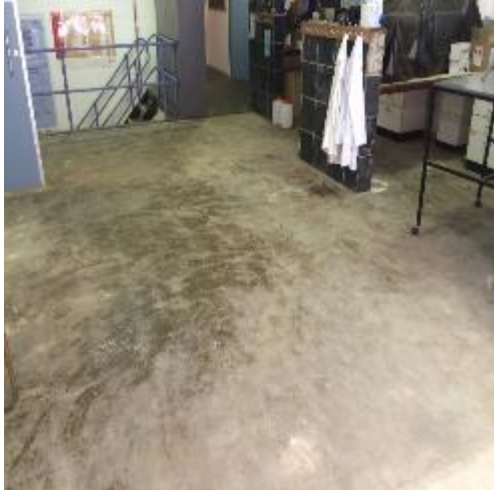
Figure 1: Basement 1 slab finished, tiles completely removed from the whole Basement 1 floor.

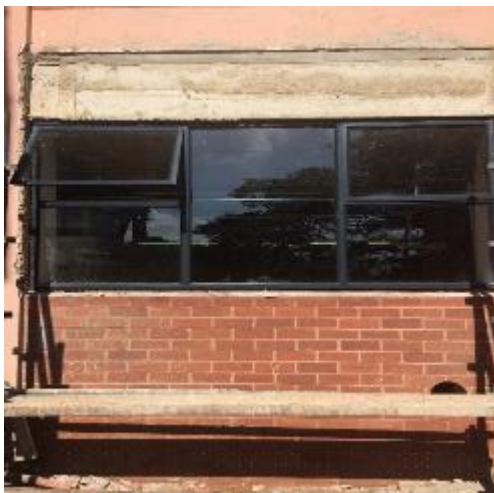
Figure 3: New window installed on the wash basin wall area.

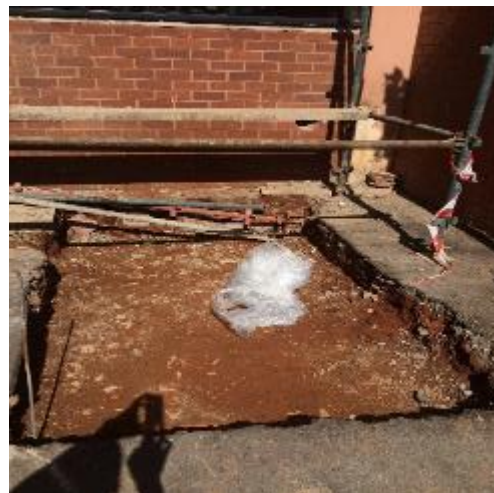
Figure 4: Tar concrete removed from the wash station.

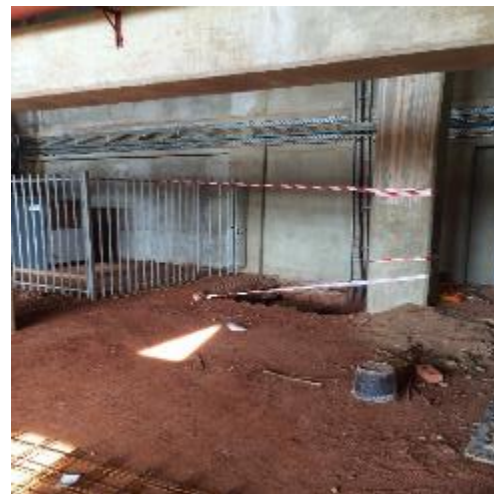
Figure 6: Gas cylinder storage area 2.

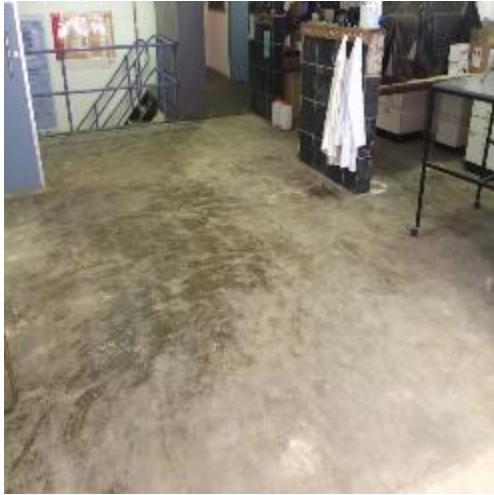
Figure 1: Basement 1 slab finished, tiles completely removed from the floor.

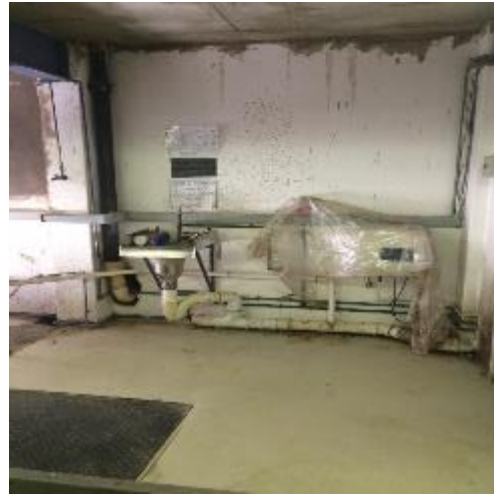
Figure 2: Sink area, scaffolding partially removed, coldroom is accessible.

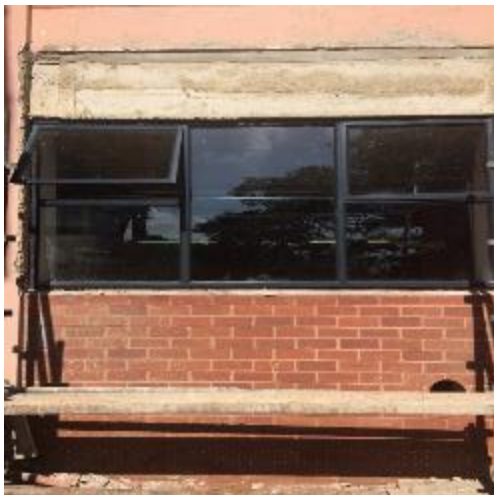
Figure 3: New window installed on the wash basin wall area (outside).

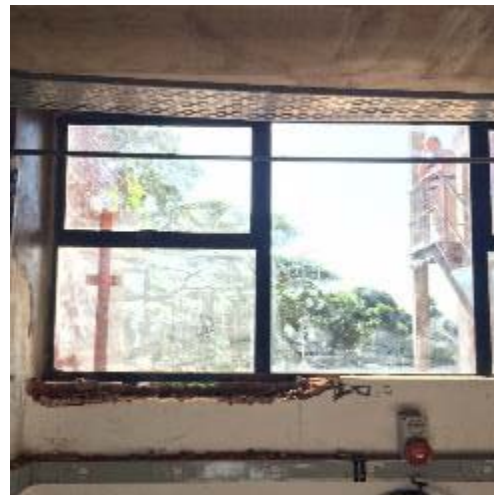
Figure 4: New window installed on the LaDePa area, view from the inside.

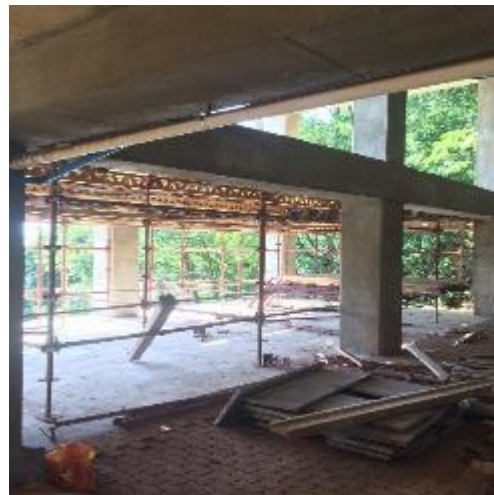
Figure 6: Gas cylinder storage area 1 with concrete foundation and scaffolding.

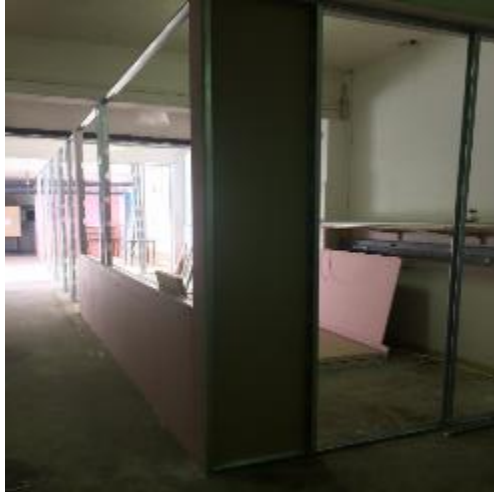
Figure 1: Partitioning of the lab.

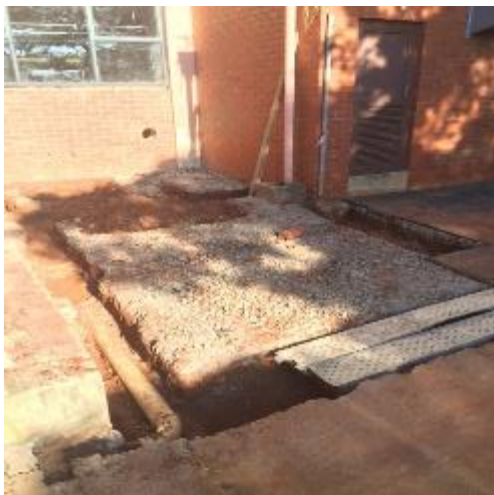
Figure 4: New window. LaDePa region (inside) and wash basin (outside).

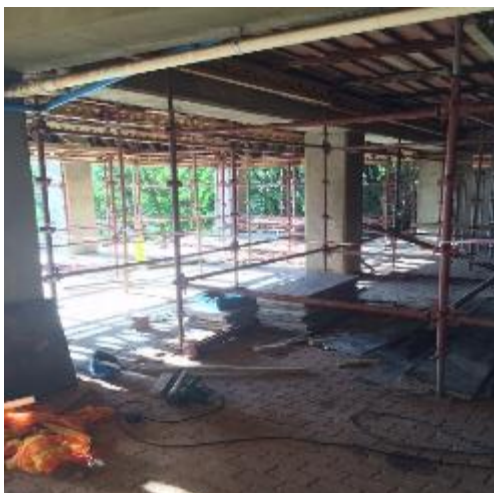
Figure 6: Gas cylinder storage area 2

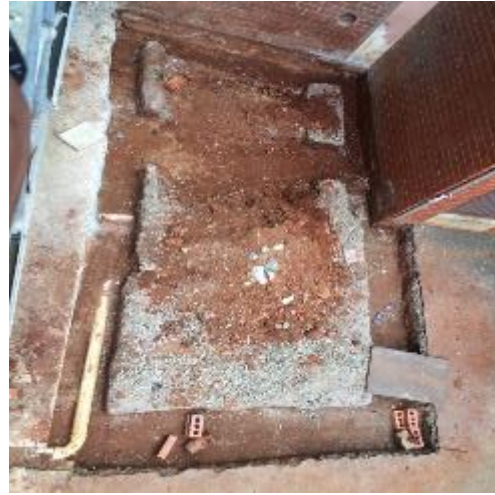
Figure 3: New slab foundation with grid layer (underpinning).

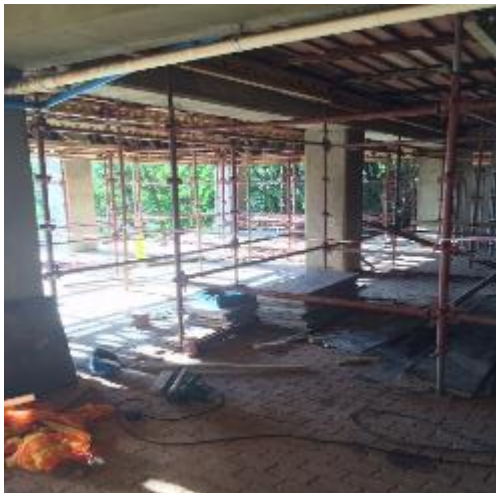
Figure 6: scaffolding spanning across the gas cylinder storage area 1 and area 2.

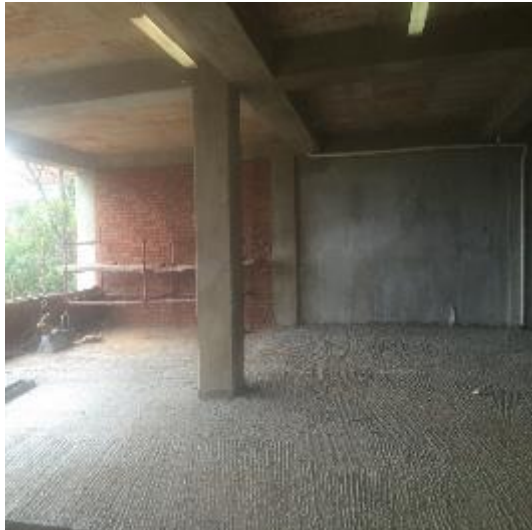
Figure 4: Slab layer completed outside the office area, above gas cylinder storage area 1.

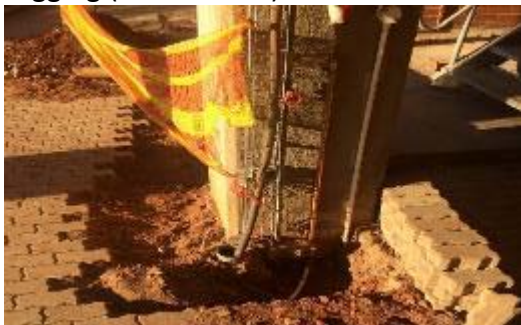
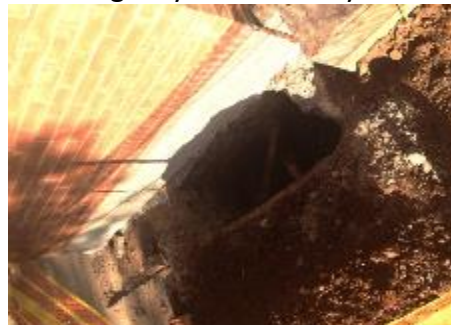
Digging (excavations) outside the wash area and emergency exit stairway.

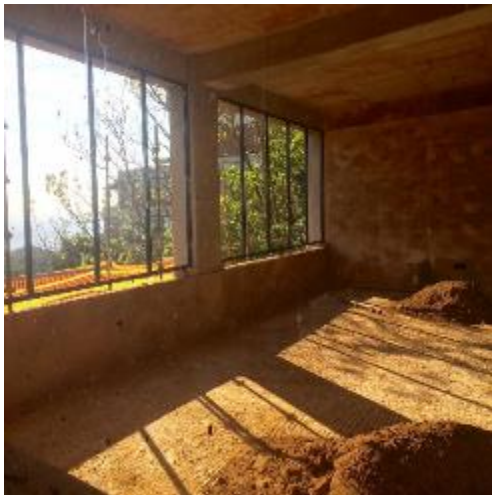
Figure 2: New office area closed up and plastered, above gas cylinder storage area 1.

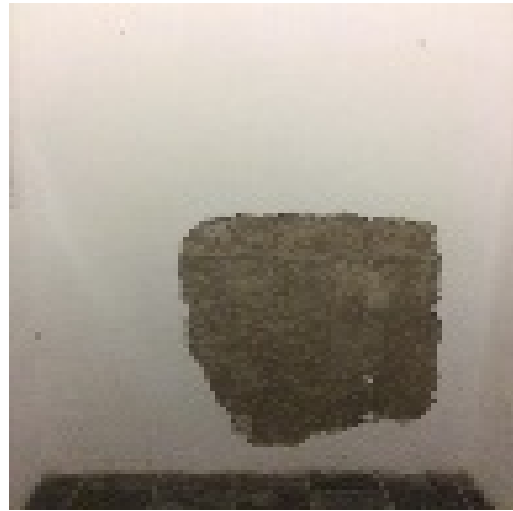
Figure 3.1: Hole made on new office area wall.

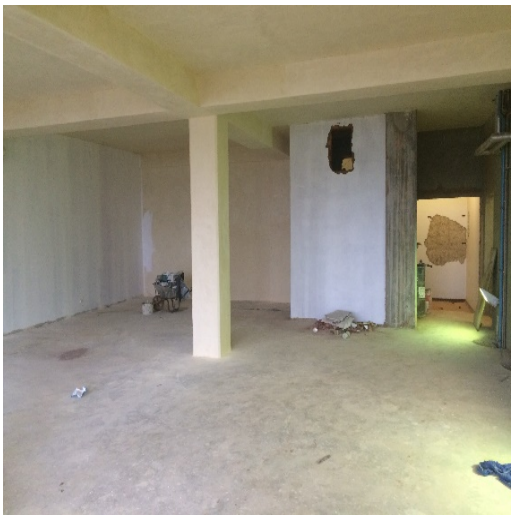
Figure 3.2: Outside the hole of the office area.

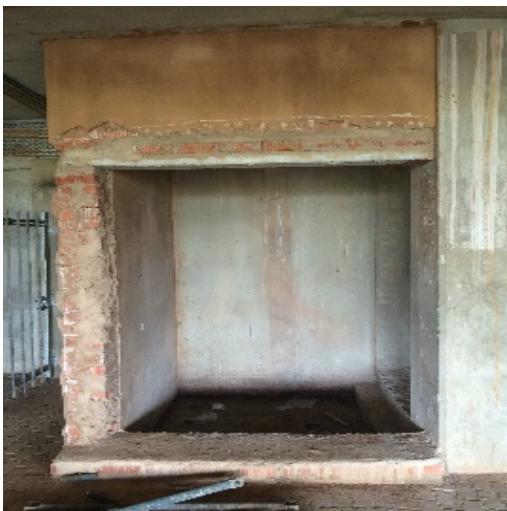
Figure 3: Lift shaft to gas storage areas

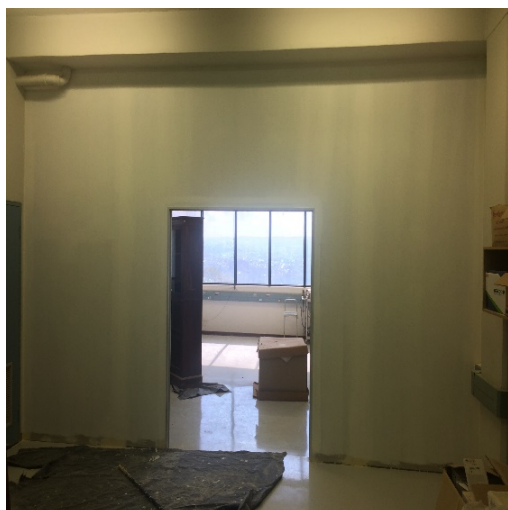
Figure 1: Partitioning of the new lab area/old postgraduate area first coat.

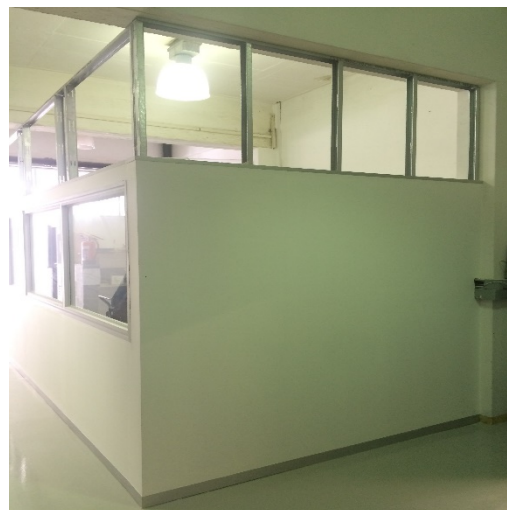
Figure 2: Lab partitions second coat of paint.

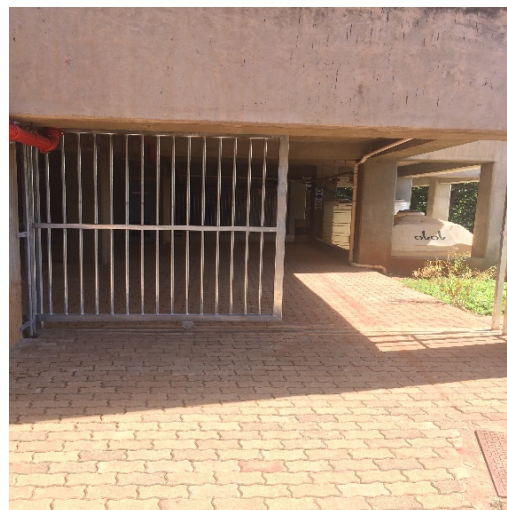
Figure 4: Gate for the gas cylinder storage area.

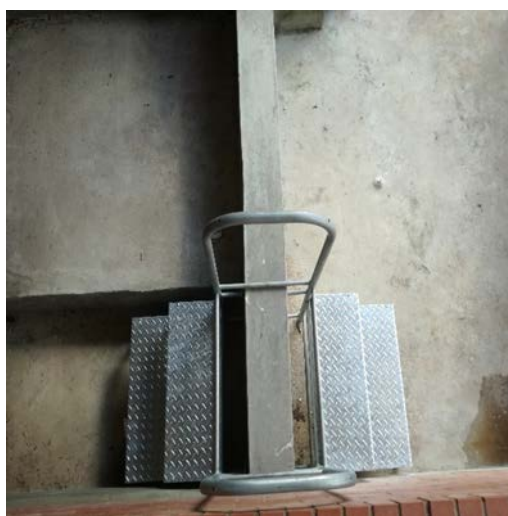
Figure 5: Wash station stair case changed.

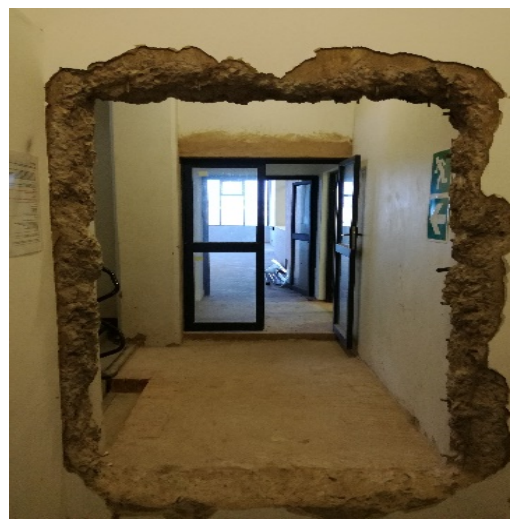
Figure 2: Wall broken down outside basement lift.

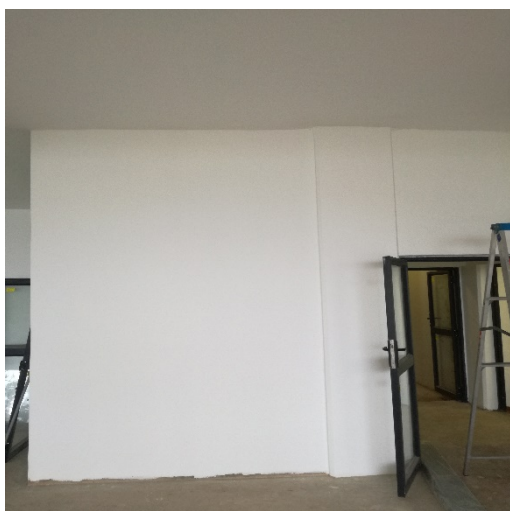
Figure 3.1: New office area wall replenished after lift being completed.

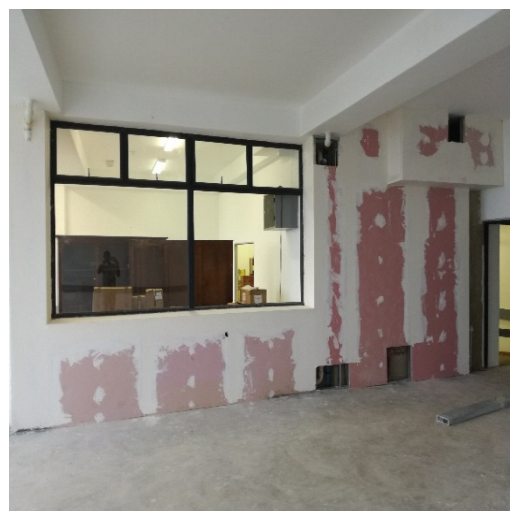
Figure 3.2: New window and walls in the new office area.

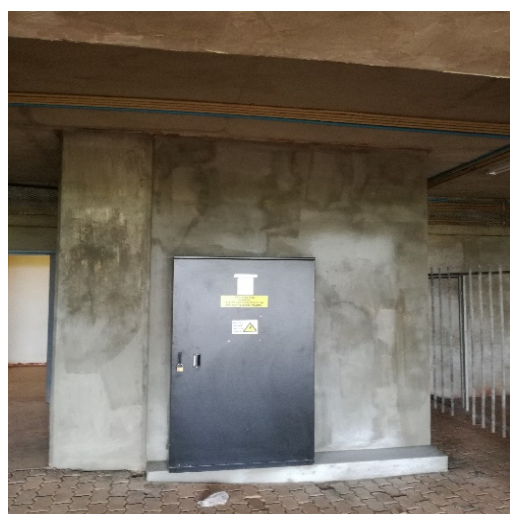
Figure 4.1: Lift cover in gas area storage area.

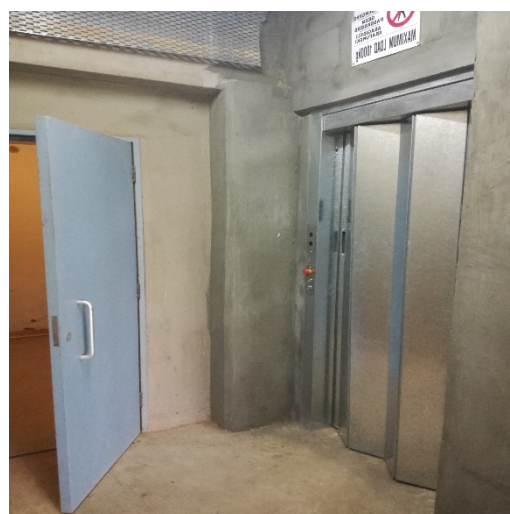
Figure 4.2: New lift from the gas storage area.

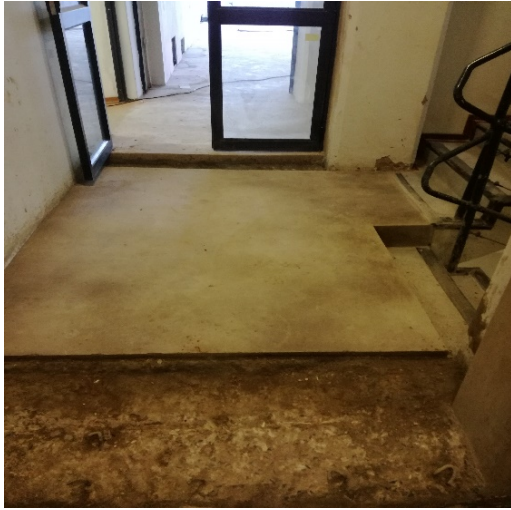
Figure 1: New door and lift entrance (foyer).

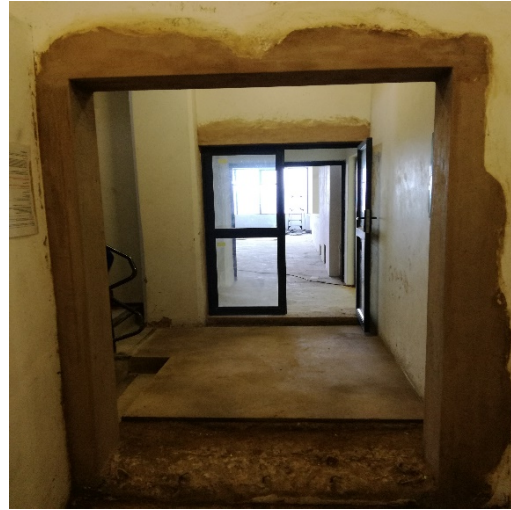
Figure 2: New foyer and ramp in progress.

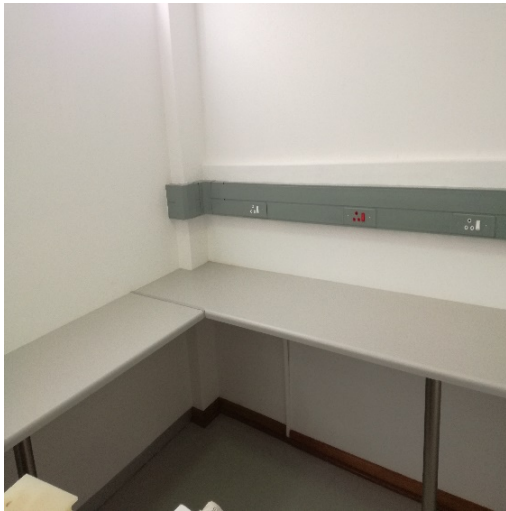
Figure 3.1: New benchtops fitted in partitions.

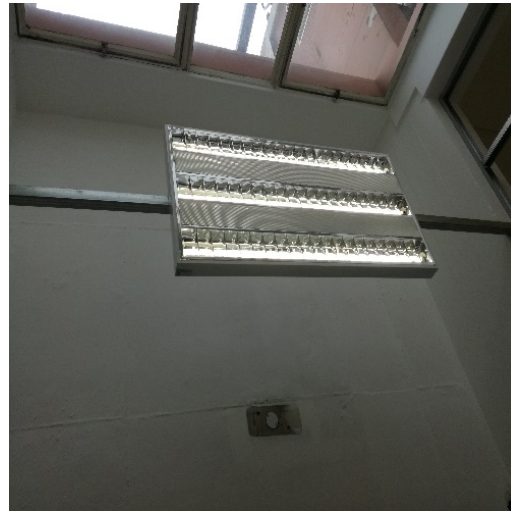
Figure 3.2: New lights fitted in partitions

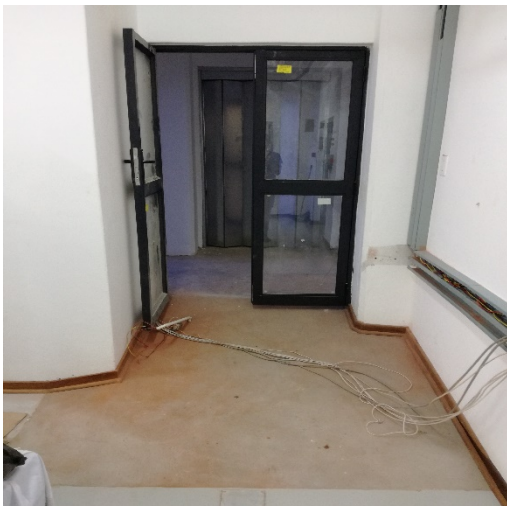
Figure 4.1: Work done on trunkings.

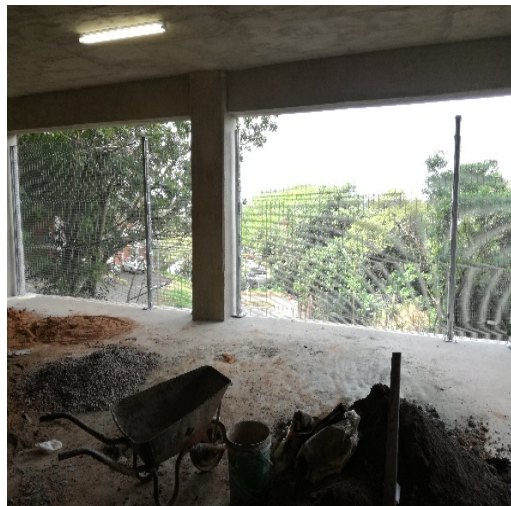
Figure 4.2: Basement area fitted with a fence.

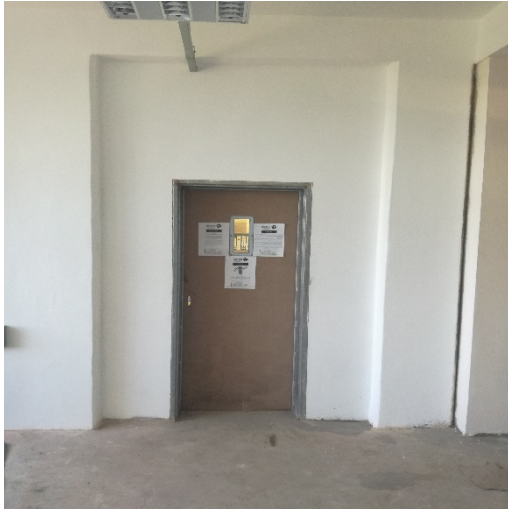
Figure 1: Door between meeting lounge and new office area.

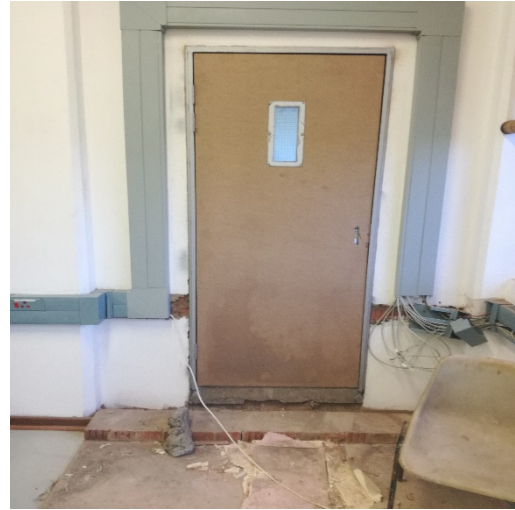
Figure 2: New trunking and step fitted on the meeting lounge side.

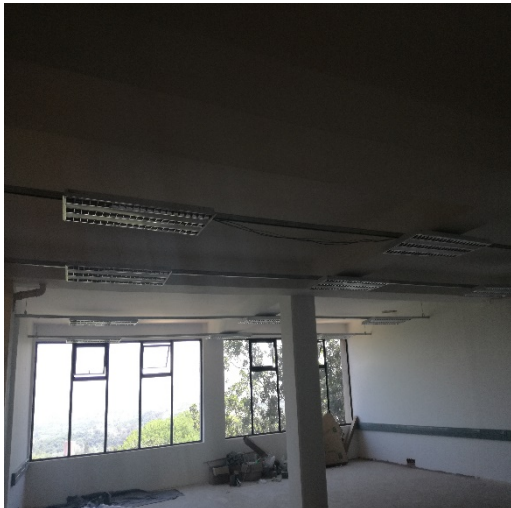
Figure 3.1: New lights fitted and work done on windows in the new office area.

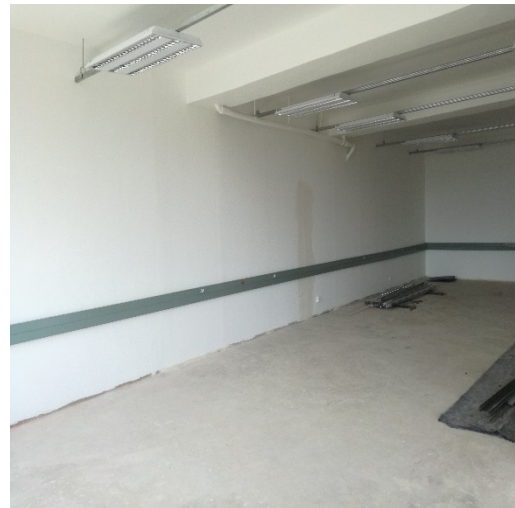
Figure 3.2: New lights and trunking fitted on the new office area.

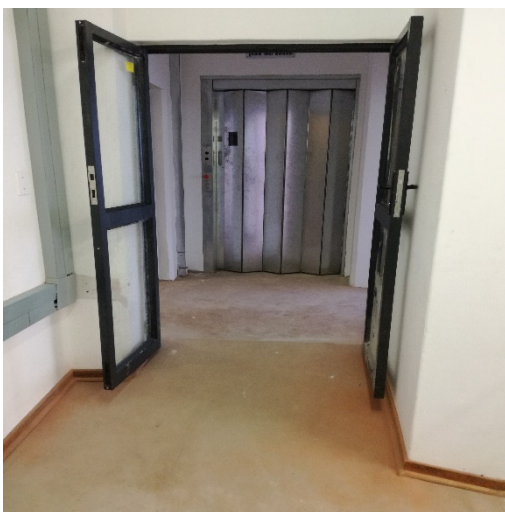
Figure 4.1: Old trunking cables completely removed on walking path.

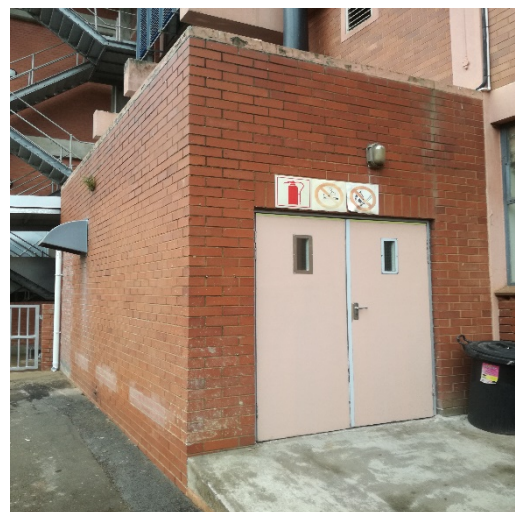
Figure 4.2: Chemical storage room new doors fitted.

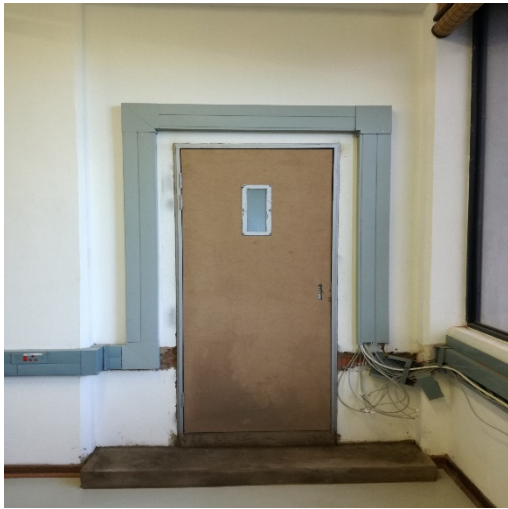
Figure 1: New step on the boardroom area door.

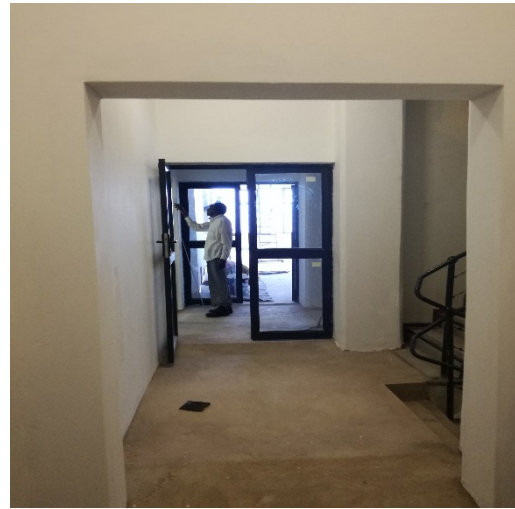
Figure 2: New foyer ramp from the old basement lift finished.

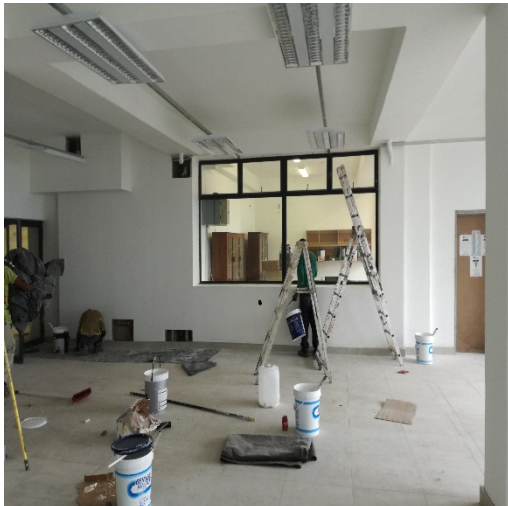
Figure 3.1: Finishes on the new office area walls.

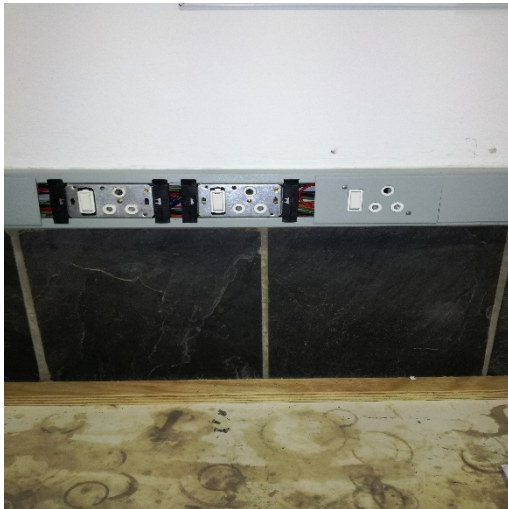
Figure 4.1: Work done on trunking in the basement and mezzanine level.

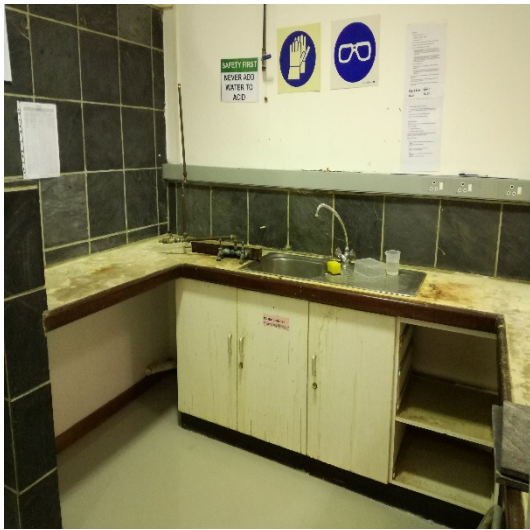
Figure 1: Workstations and gas lines cleared for carpenters.

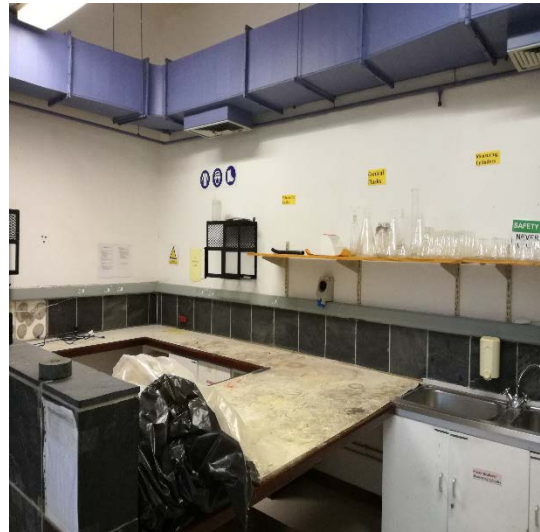
Figure 2: Cleanroom workstations and gas lines cleared for carpenters.

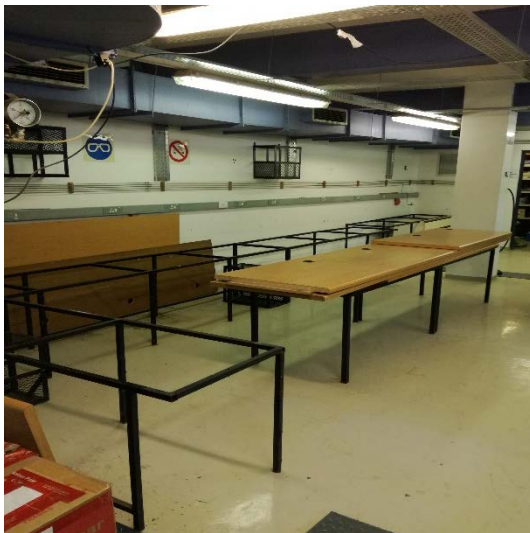
Figure 3: Mezzanine work stations cleared with frames remaining for carpenters.

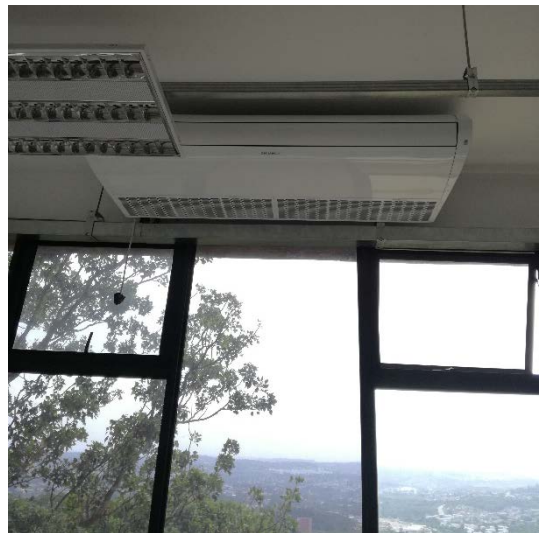
Figure 4: New office area fitted with air conditioners.

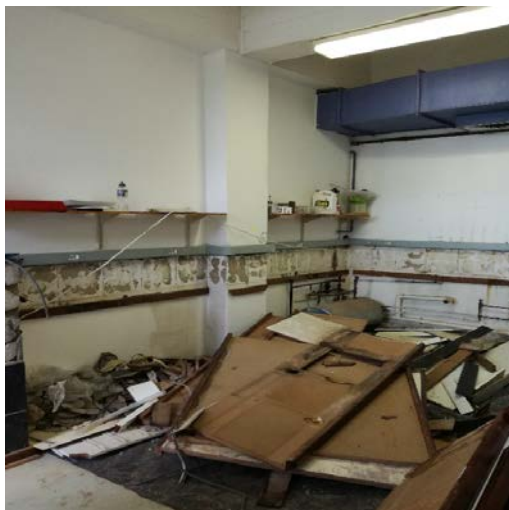
Figure 1: Removal of workstations and cupboards.

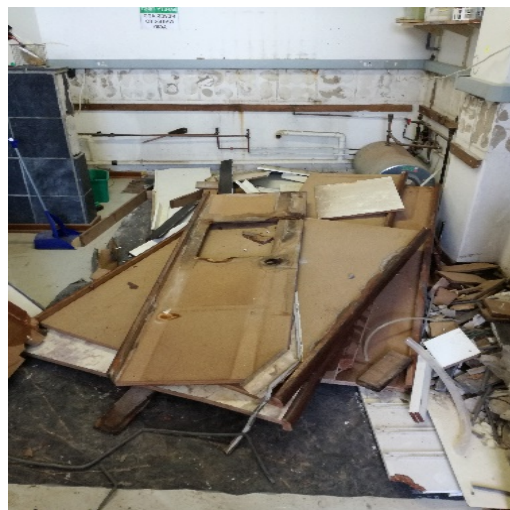
Figure 2: Removal of workstations and cupboards.

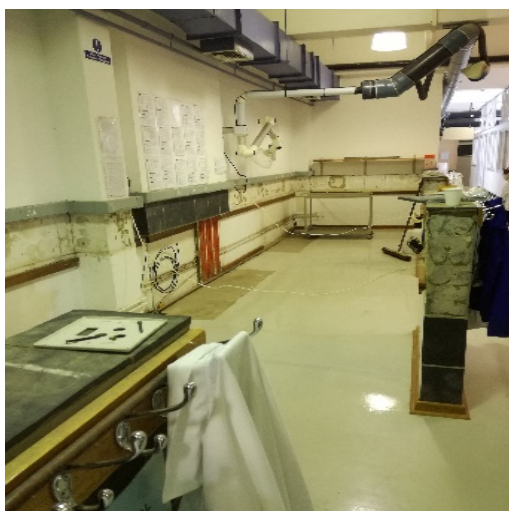
Figure 3.1: Laboratory floors completely stripped.

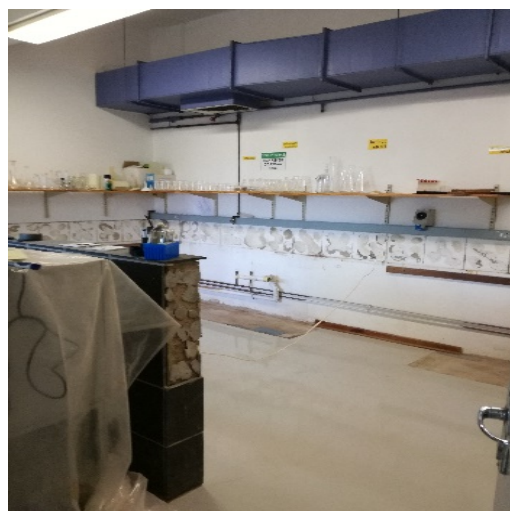
Figure 3.2: Clean room floors completely cleared.

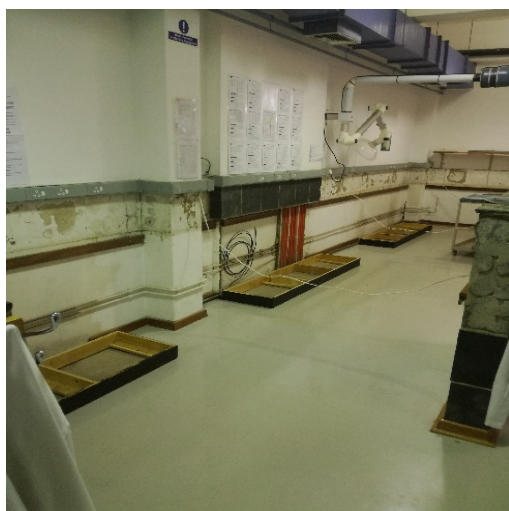
Figure 4.1: Installation of bases for the cupboards.

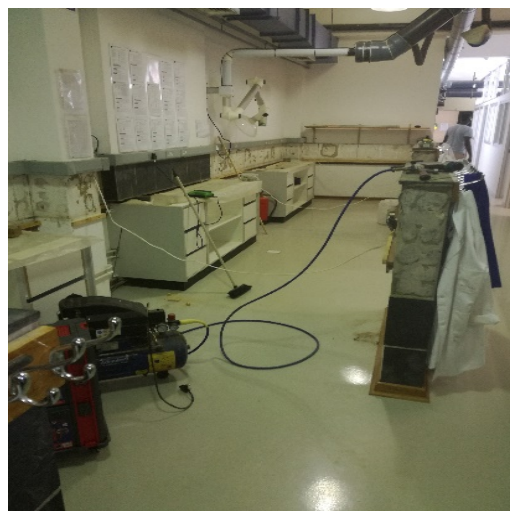
Figure 5: Cupboards installations.

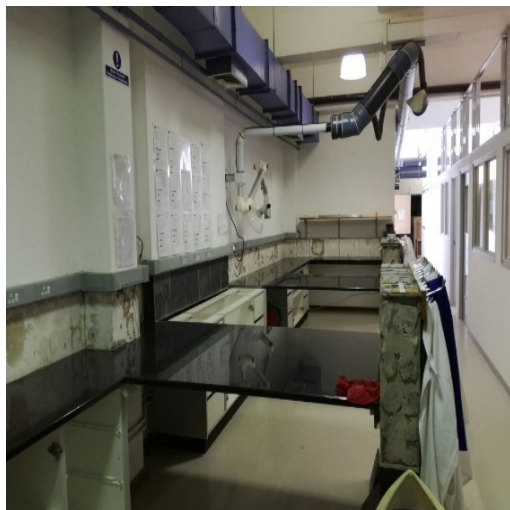
Figure 1: Granite tops fitting on island stations.

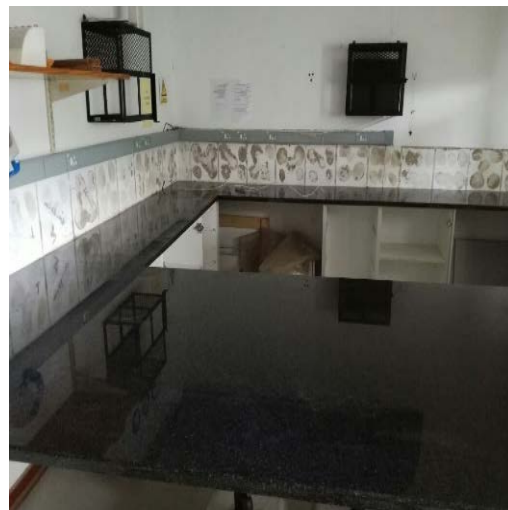
Figure 2: Granite tops fitting in clean room.

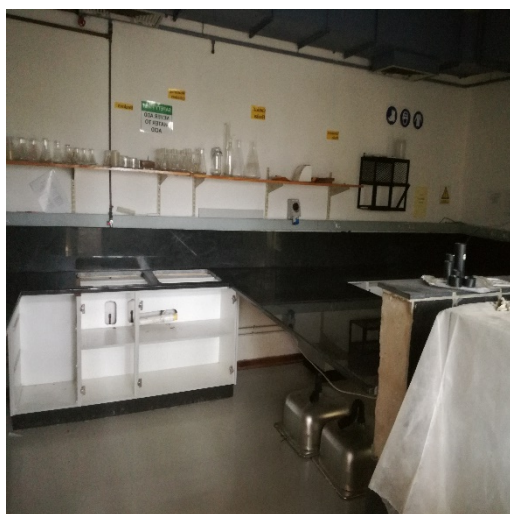
Figure 3.1: Granite tops fitting in clean room.

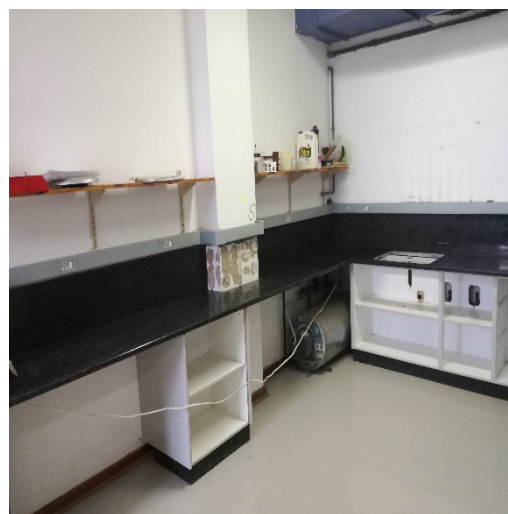
Figure 3.2: Granite tops fitting in sink area.
