Building Portfolio

This document tracks the progress of the building and renovation of the Pollution Research Group in the basement of the Chemical Engineering Building at the University of KwaZulu-Natal. This document provides a regular update of the progress from the start of the alterations up to the date of completion.

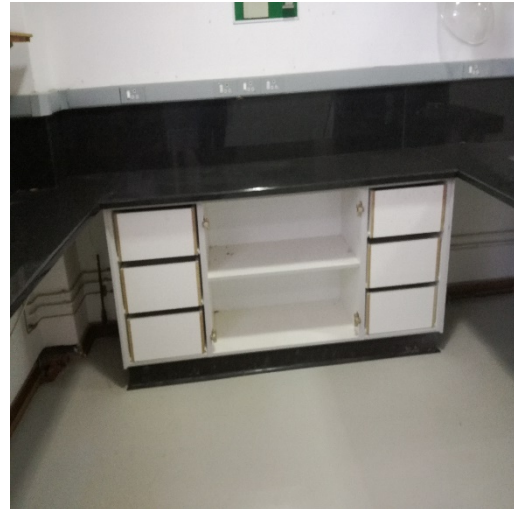
Figure 2: Drawers fitted only on these cupboards.

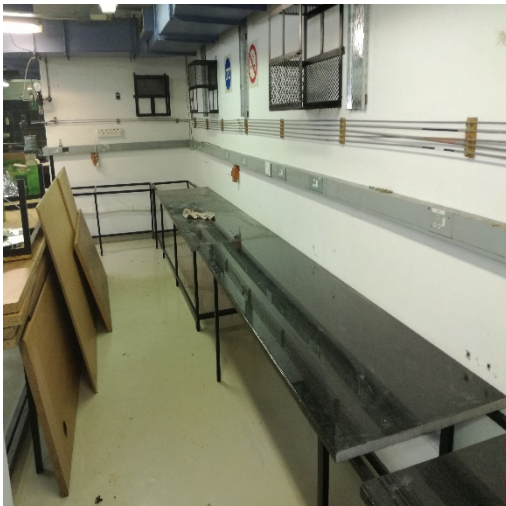
Figure 3: Mezzanine level granite fitted.

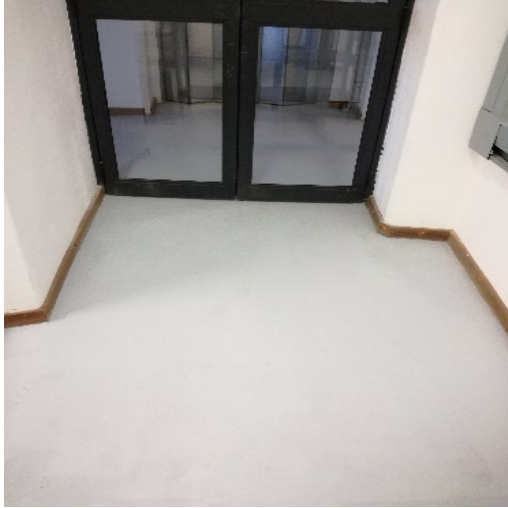
Figure 1: First coat of paint on the ramp.

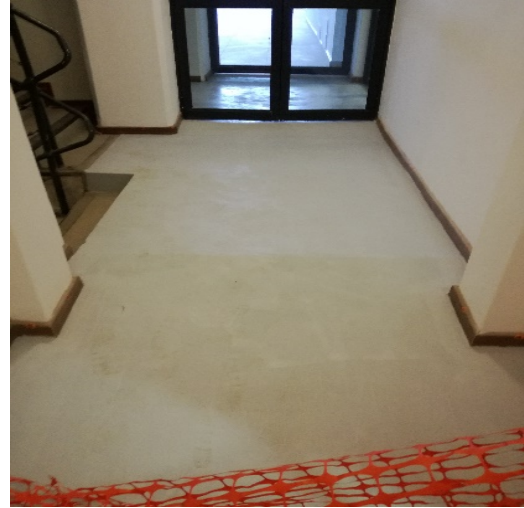
Figure 2: First coat of paint on foyer section.

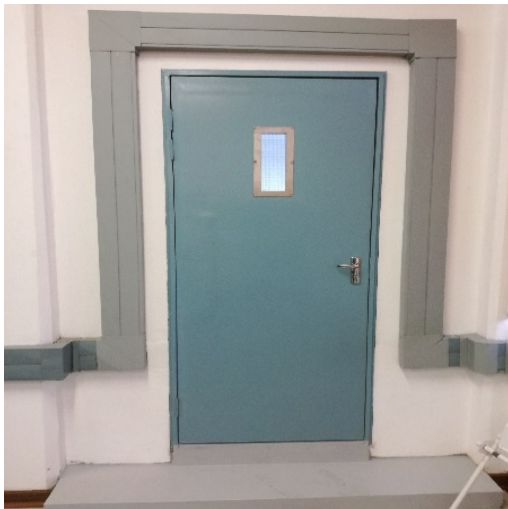
Figure 3.1: Meeting room door completed.

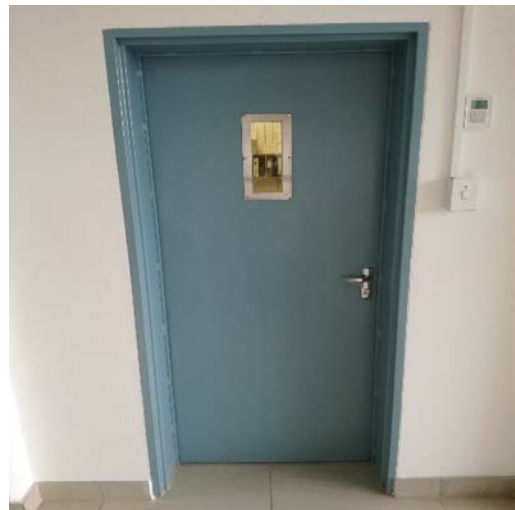
Figure 3.2: Office door completed.

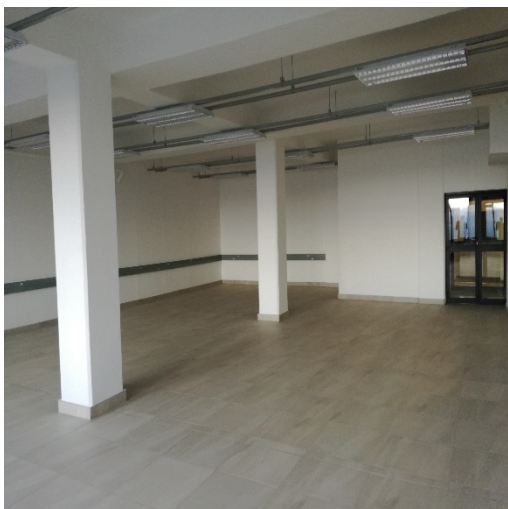
Figure 4: New office area completed.

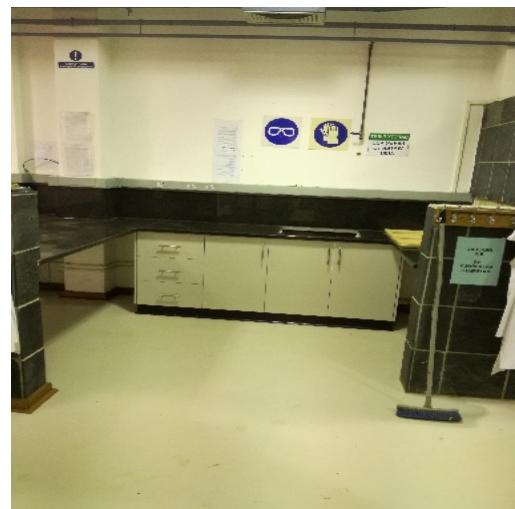
Figure 5: Doors and splash backs fitted on cupboards.

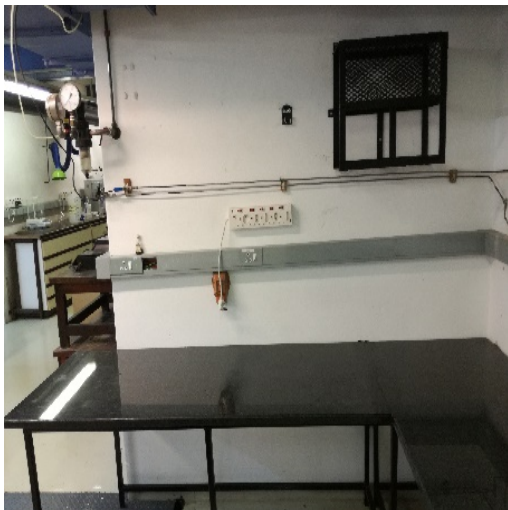
Figure 3.1: Mezzanine level granite tops.

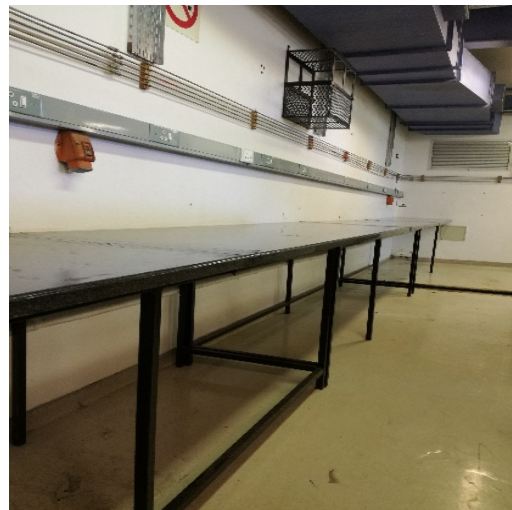
Figure 3.2: Mezzanine level granite tops.

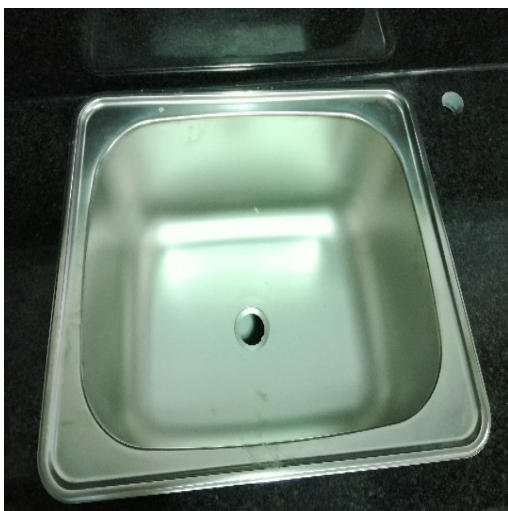
Figure 4: Sinks not fitting properly in granite tops.

Figure 4.1: Sinks fitted properly after granite adjustment.

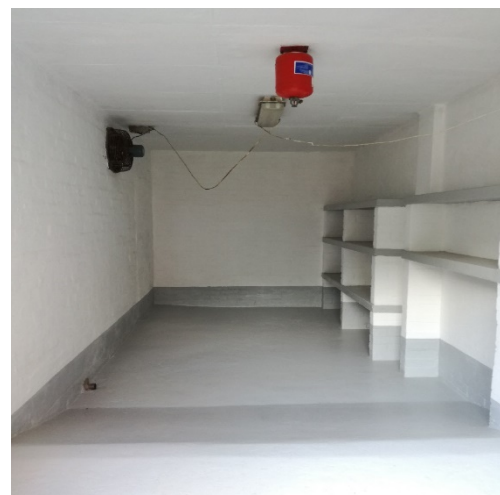
Figure 5: Floor for chemical waste management inside the chemical room

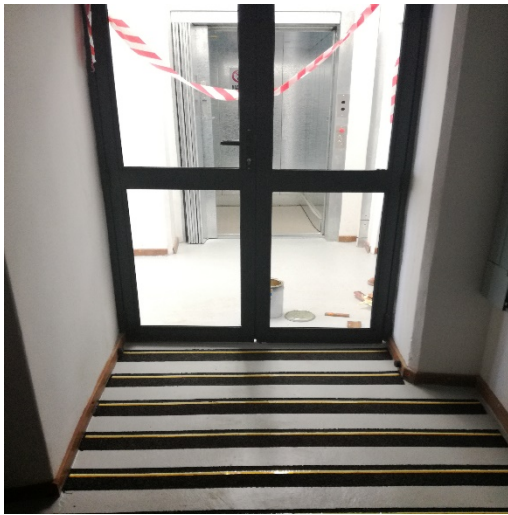
Figure 1: Non-slip tracks fitted on ramp.

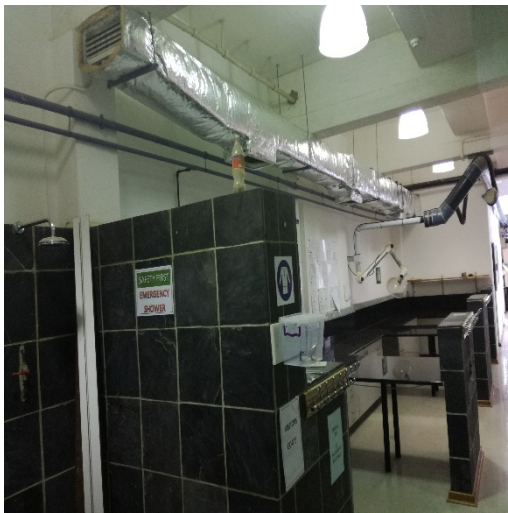
Figure 3.1: Air duct insulation.

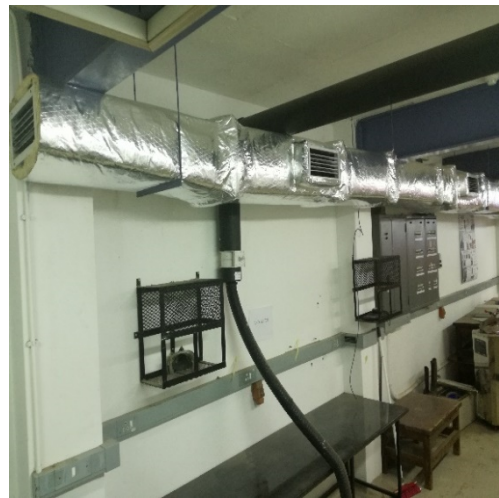
Figure 3.2: Air duct insulation.

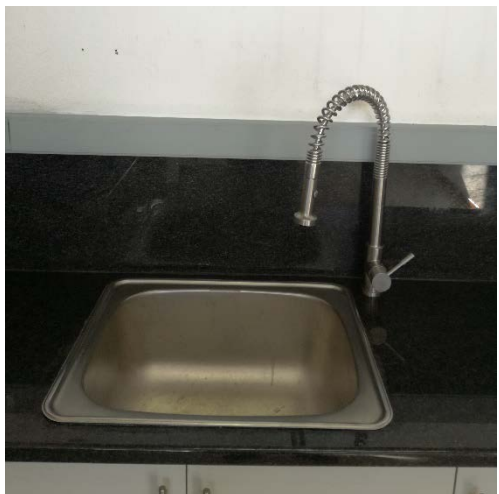
Figure 4.2: Taps fitted.

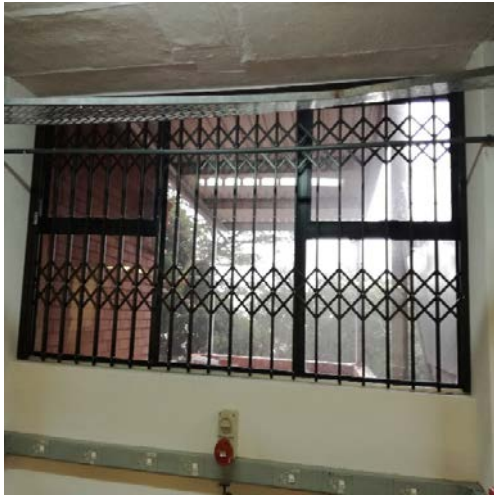
Figure 1: Window burglar guards installed.

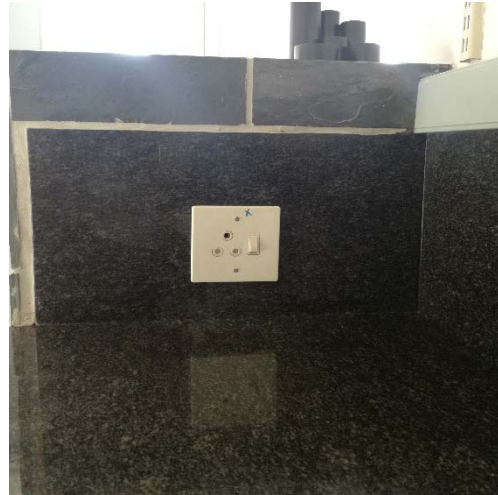
Figure 2: Plug points fitted into the granite.

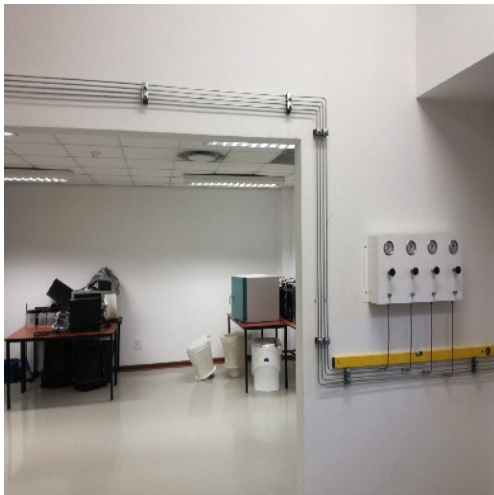
Figure 3.1: Gas lines and regulators installed in the laboratory.

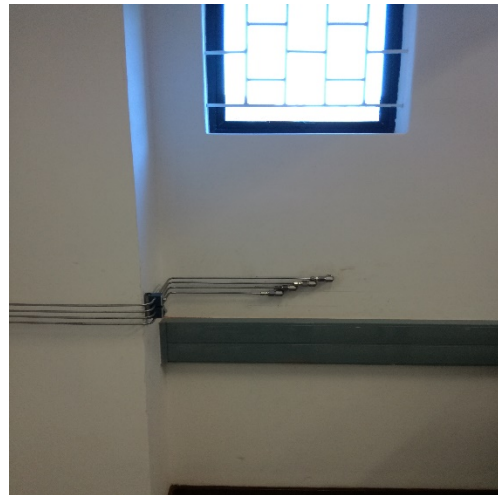
Figure 3.2: gas lines going through the wall.

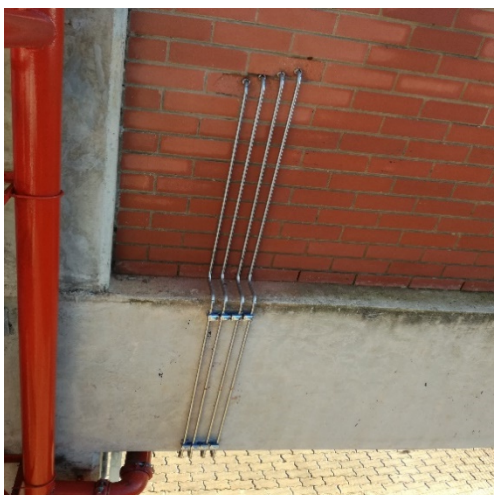
Figure 3.3: Gas lines going into the gas cylinders from the lab.

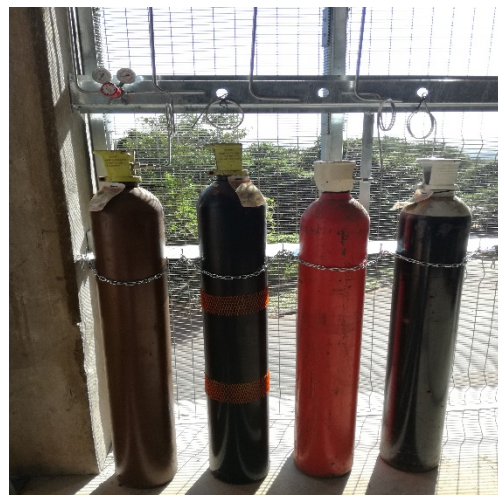
Figure 3.4: Gas cylinders in storage area.

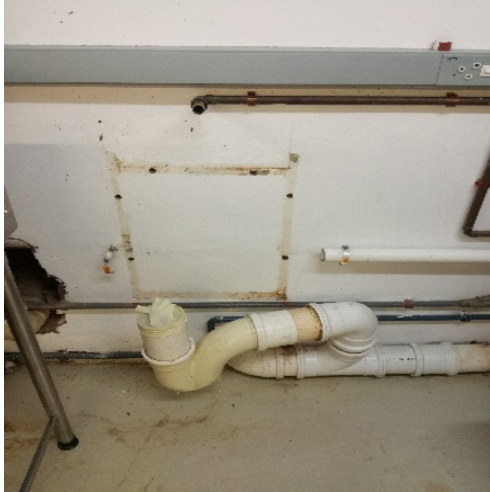
Figure 1: Sluice removed in the lab.

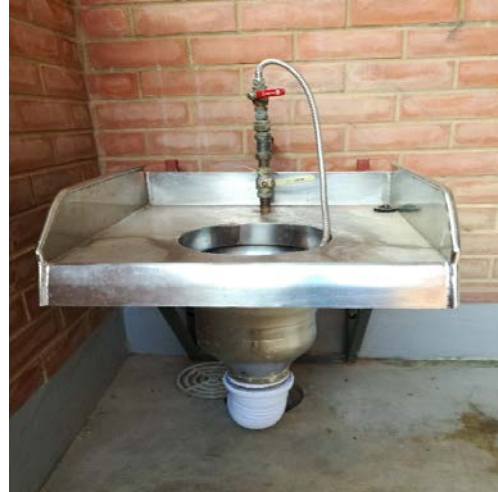
Figure 2: Sluice moved into the wash area.

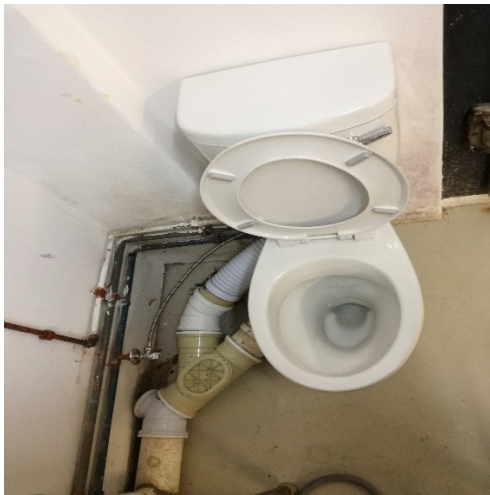
Figure 3.1: Toilet installed outside the coldroom.

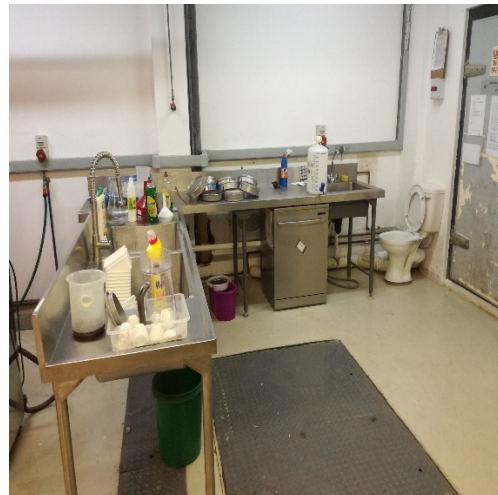
Figure 3.2: Sink positioned and plumbing done.

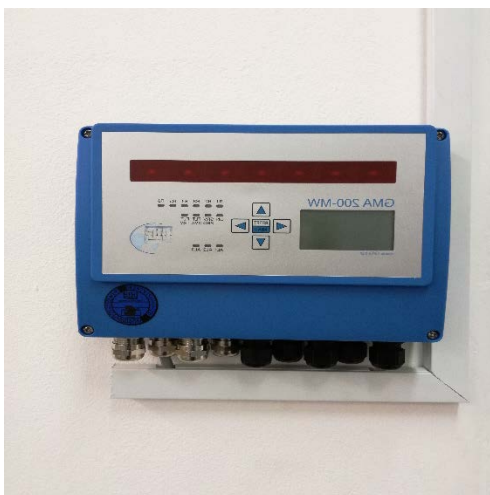
Figure 3.3: Gas leak detectors installed in analytical lab (25 July 2017).

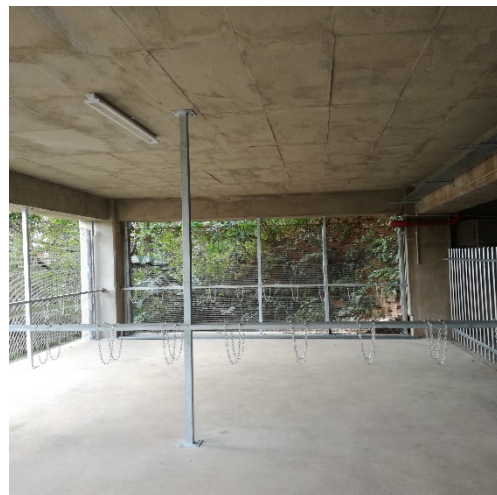
Figure 3.4: Gas partitioning and chains fitted for Chem Eng.

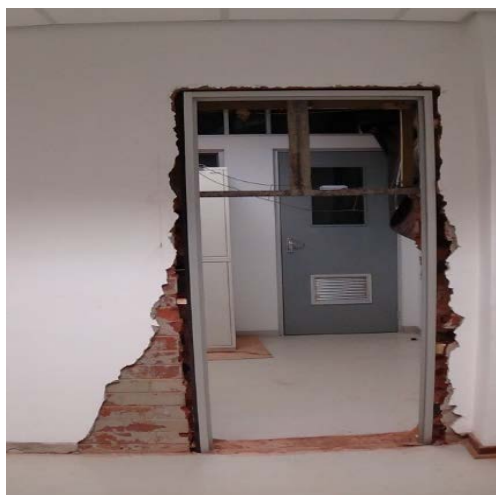
Figure 1: Frame fitted after breaking the wall view 1.

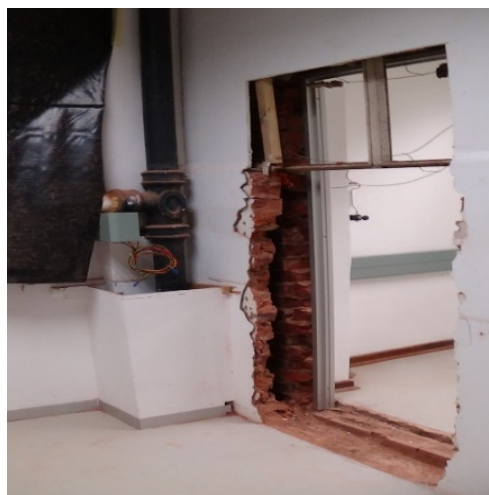
Figure 2: Frame fitted after breaking the wall view 2.

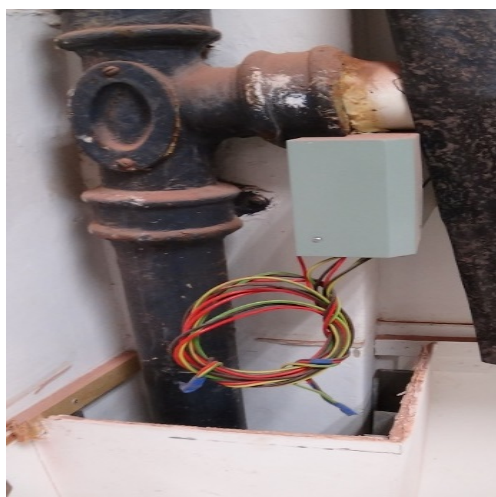
Figure 3: Trunking wire exposed.

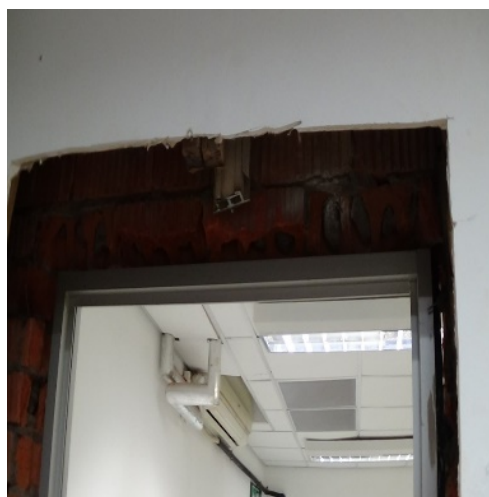
Figure 4: Closing the frame gap.

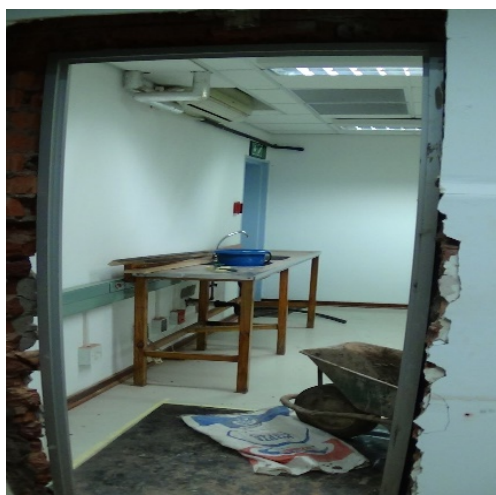
Figure 5: Closed gap view from chemistry room.

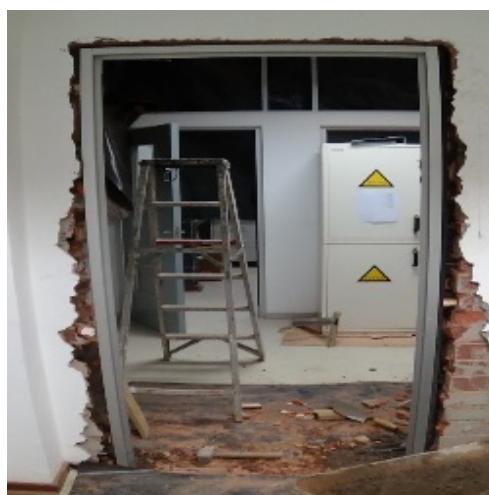
Figure 6: Closed gap from analytical room.

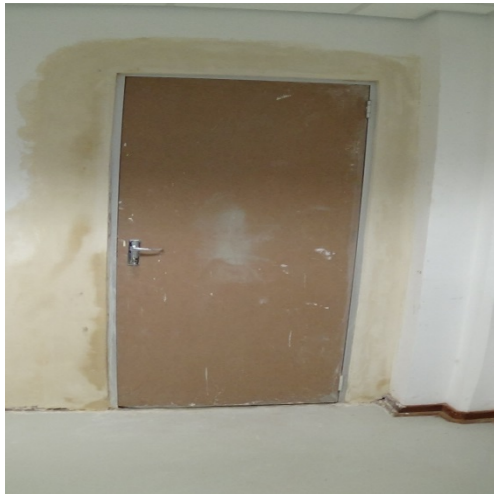
Figure 1: Wall replenishing.

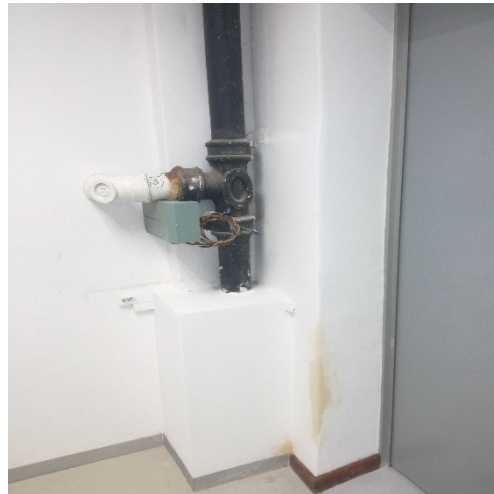
Figure 2: Exposed trunking wires.

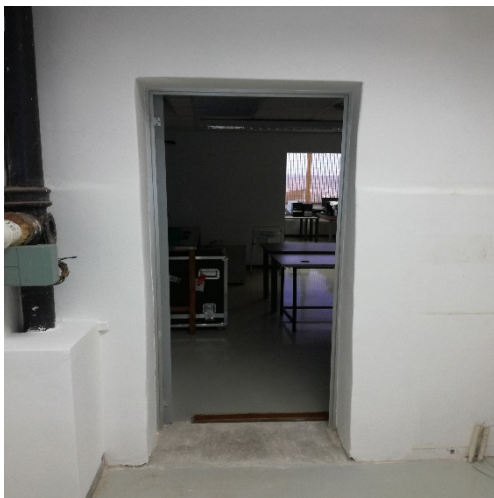
Figure 3: Completed door.

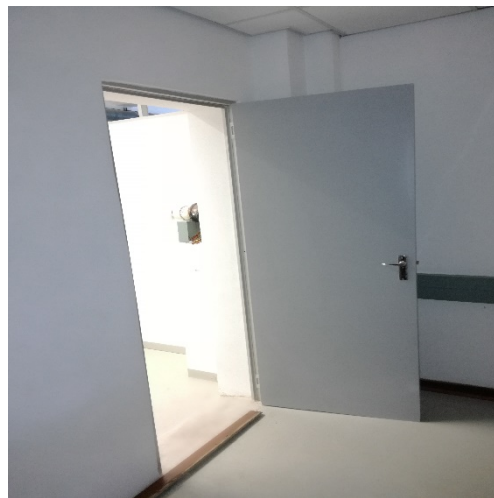
Figure 4: Opened completed door.

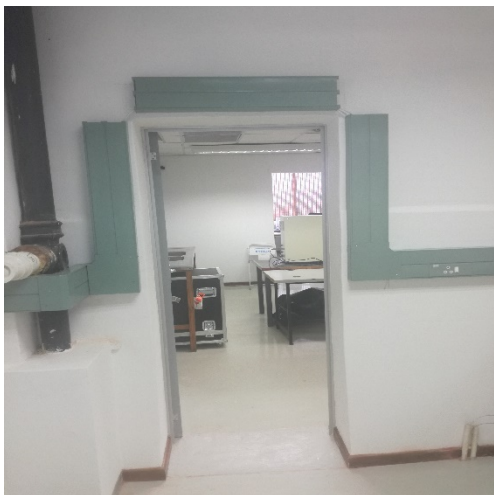
Figure 5: Fitting of the trunking in chemistry room.

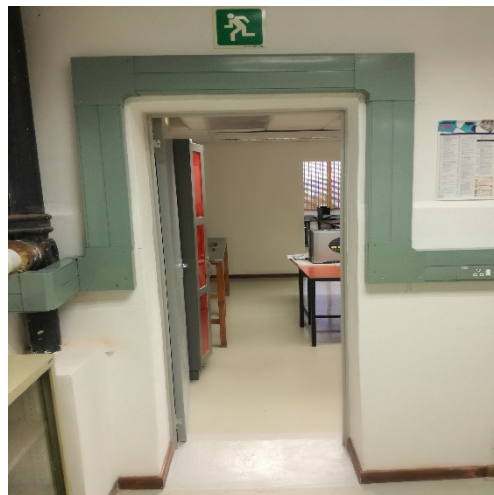
Figure 6: Completed trunking in chemistry room.

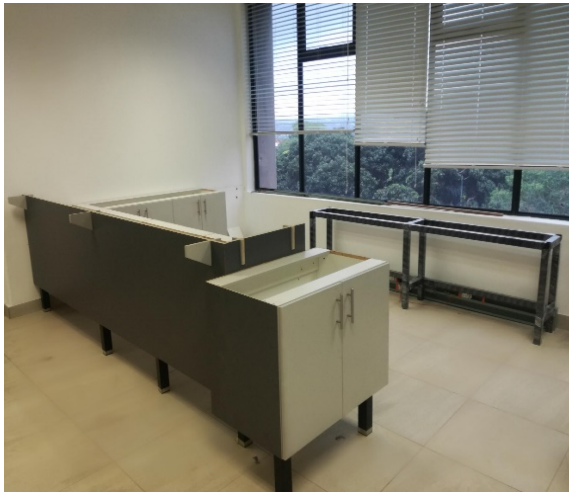
Figure 1: Cupboard frames installations.

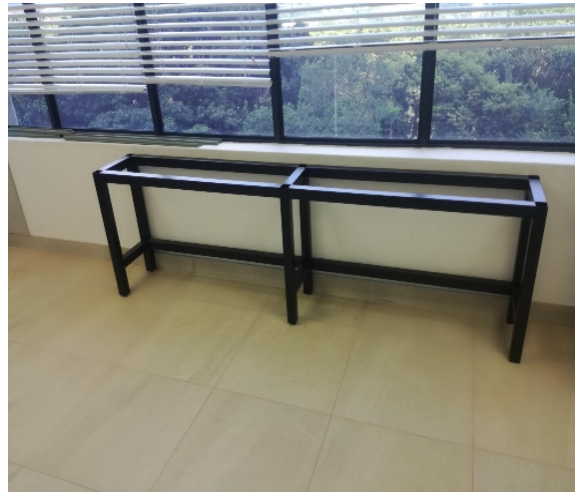
Figure 2: Frame for side table.

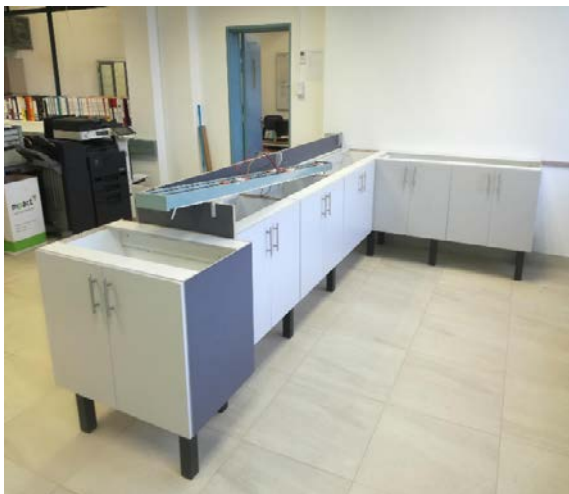
Figure 3: Trunking to be fitted on kitchen counters

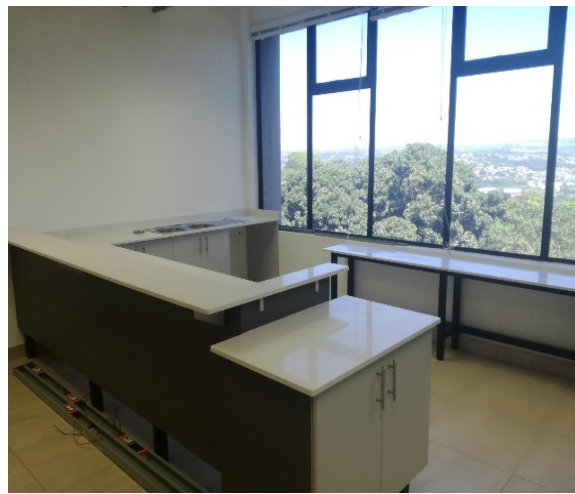
Figure 4: Side table granite fitted.

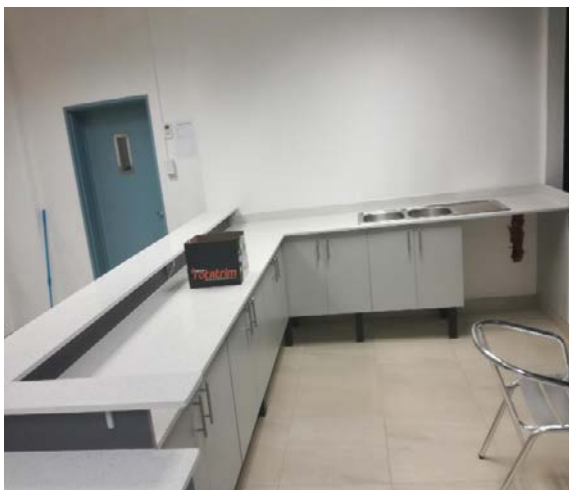
Figure 5: Granite benchtops fitted

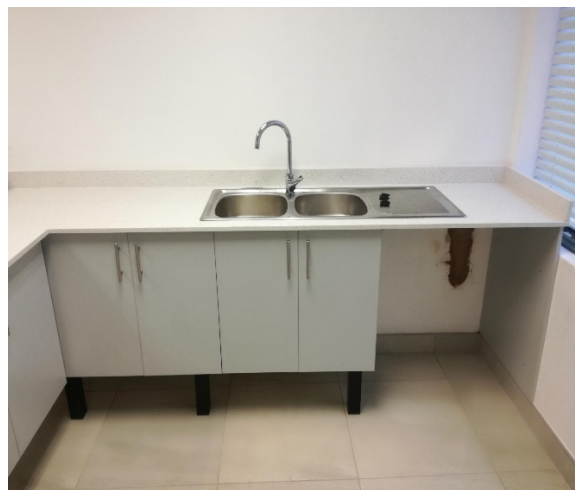
Figure 6: Sink taps fitted
